Master Plan for the Rehabilitation and Revitalisation of the Ex-Mega Rice Project Area in Central Kalimantan

PRELIMINARY ASSESSMENT OF AVAILABILITY AND ACCURACY OF HYDROLOGICAL AND ELEVATION DATA IN THE EMRP AREA

Technical Review No. 3

MARCH 2009

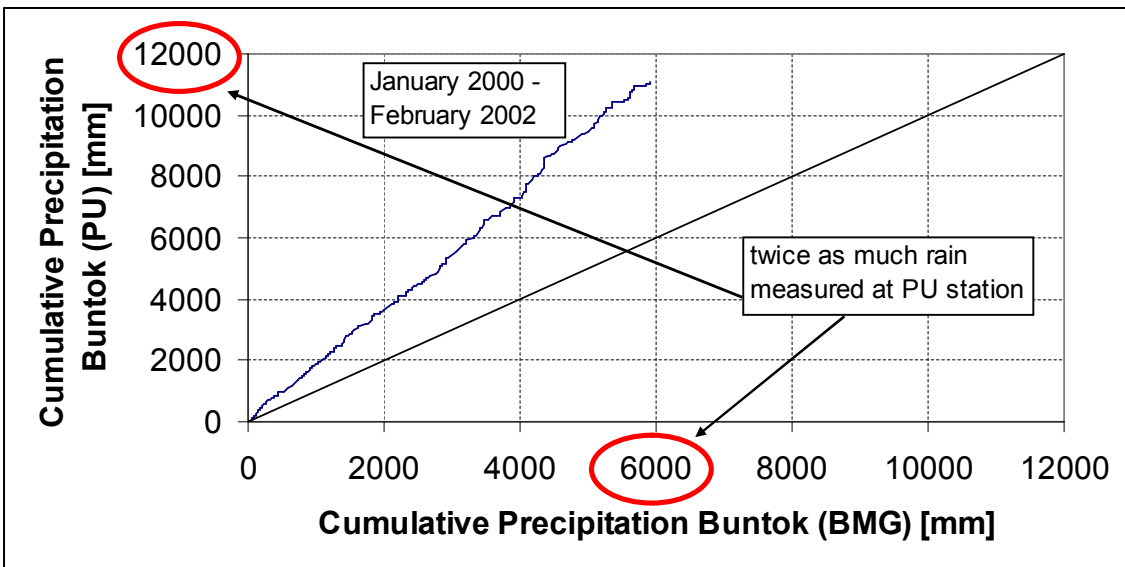
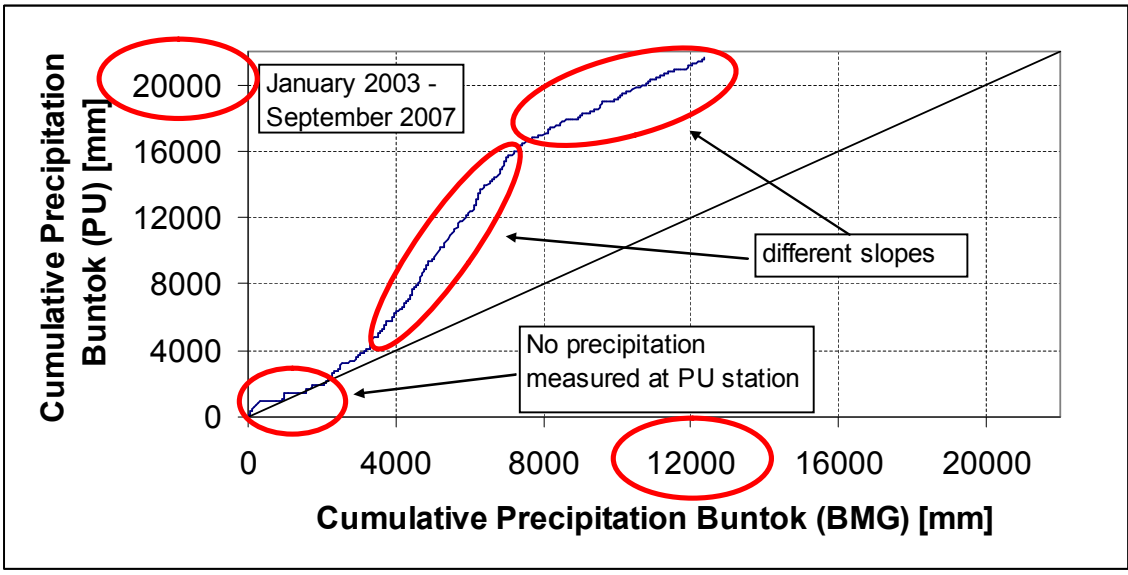
Cumulative precipitation for both Buntok and Palangka Raya is plotted in Figure 4 and shows that precipitation measured at Buntok PU station is almost twice as high compared to the Palangka Raya measurements. Despite differences because of geographic location the measurements at Buntok are clearly too high with an average annual precipitation of 4565 mm over the period 2000 – 2007, and these data can therefore not be used.

Figure 3 (top panel) Cumulative precipitation measured at Buntok by both PU and BMG for January 2000 – February 2002. Measurements by PU are twice as high compared to BMG measurements. The black line shows expected relationship. (lower panel) shows similar trend for period January 2003 – September 2007, but in addition different slopes.

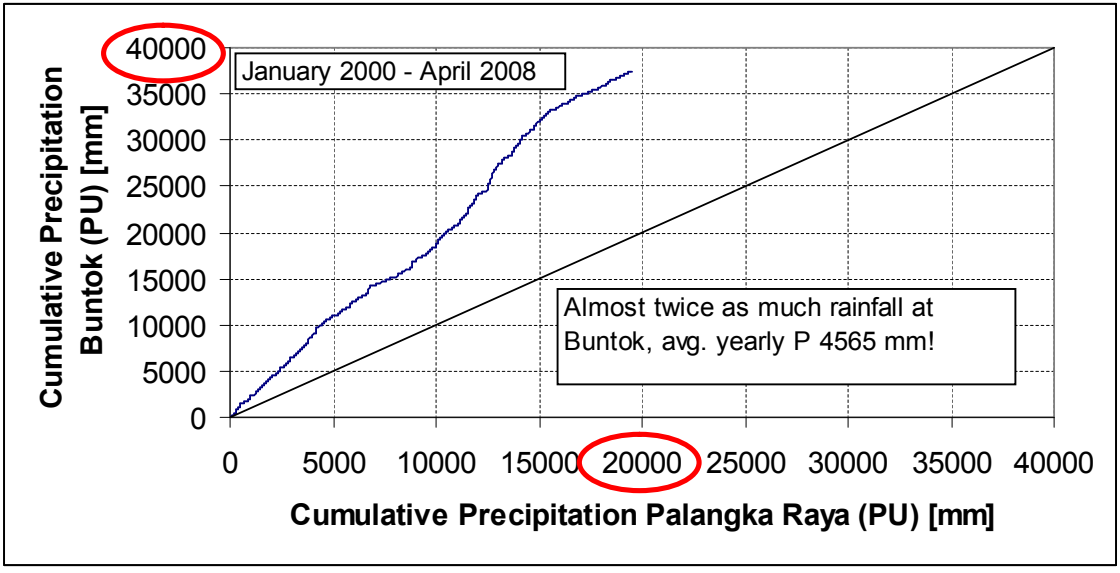
Figure 4 Cumulative precipitation measured by PU at Buntok and Palangka Raya for January 2000 – April 2008. The black line shows expected relationship.

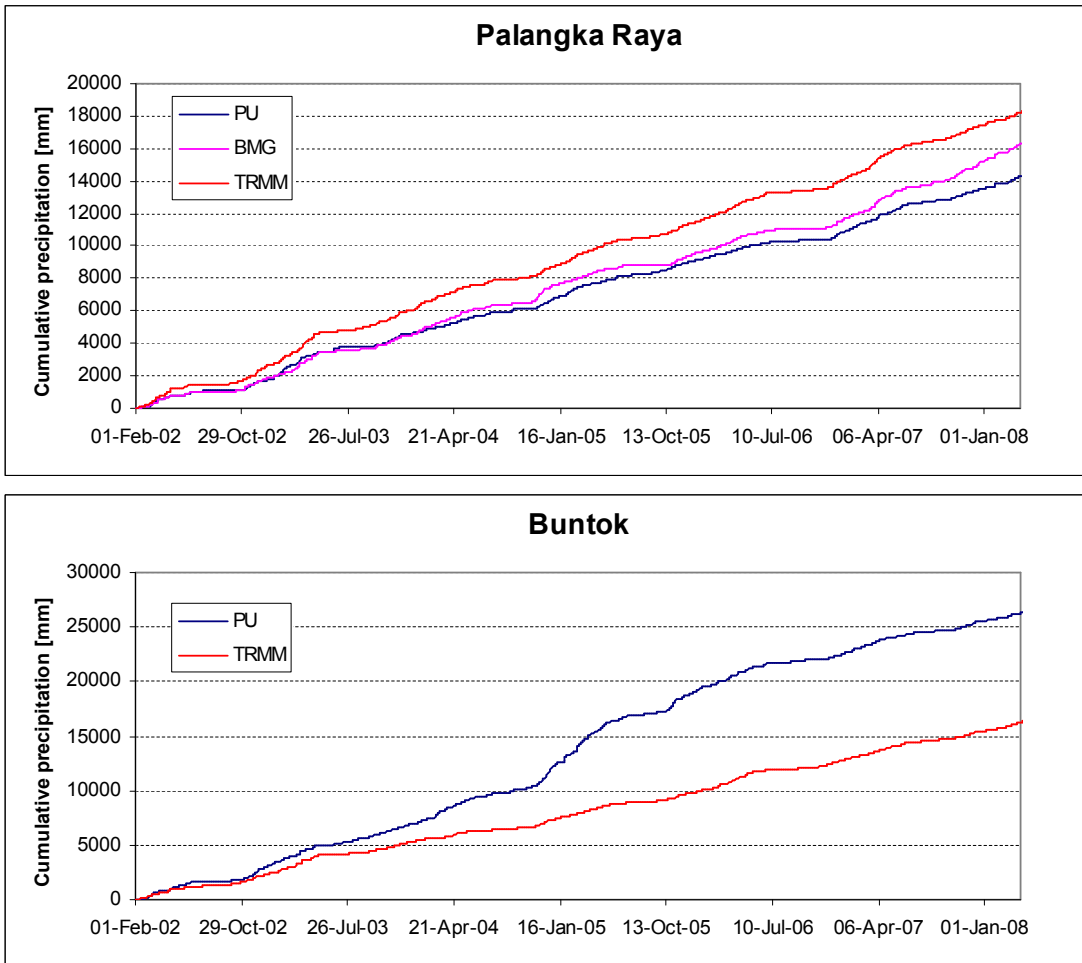
An independent check on the reliability of the current datasets is possible with satellite based precipitation observations using TRMM data available since February 2002. This is illustrated in Figure 5 where a comparison between measured cumulative precipitation and observed precipitation by the TRMM satellite is shown for Palangka Raya and Buntok. The Palangka Raya comparison gives us confidence in both manual measurements as well as the use of satellite data. From Figure 5 the following conclusions can be made. For the Palangka Raya comparison dry periods are clearly observed for all three datasets. The slopes of both PU measurements and TRMM observations are similar, while the slope of the BMG measurements is steeper, explaining the difference in annual totals with PU (up to 900 mm) as was already observed in Section 2.1.1. In 2005 a longer dry period is observed by BMG while similar for PU and TRMM observations. For the Buntok comparison the dry periods are observed as well. The slopes of measured precipitation are much steeper compared to TRMM observations, but as it was already concluded in Section 2.1.1 (Figure 3, Table 1 and Table 2) the Buntok data measured by PU are not reliable.

Figure 5 Cumulative precipitation for Palangka Raya (upper panel) and Buntok (lower panel) over the period 1 February 2002 – 30 April 2008 as measured by PU (blue line), BMG (purple line) and observed by TRMM (orange line).

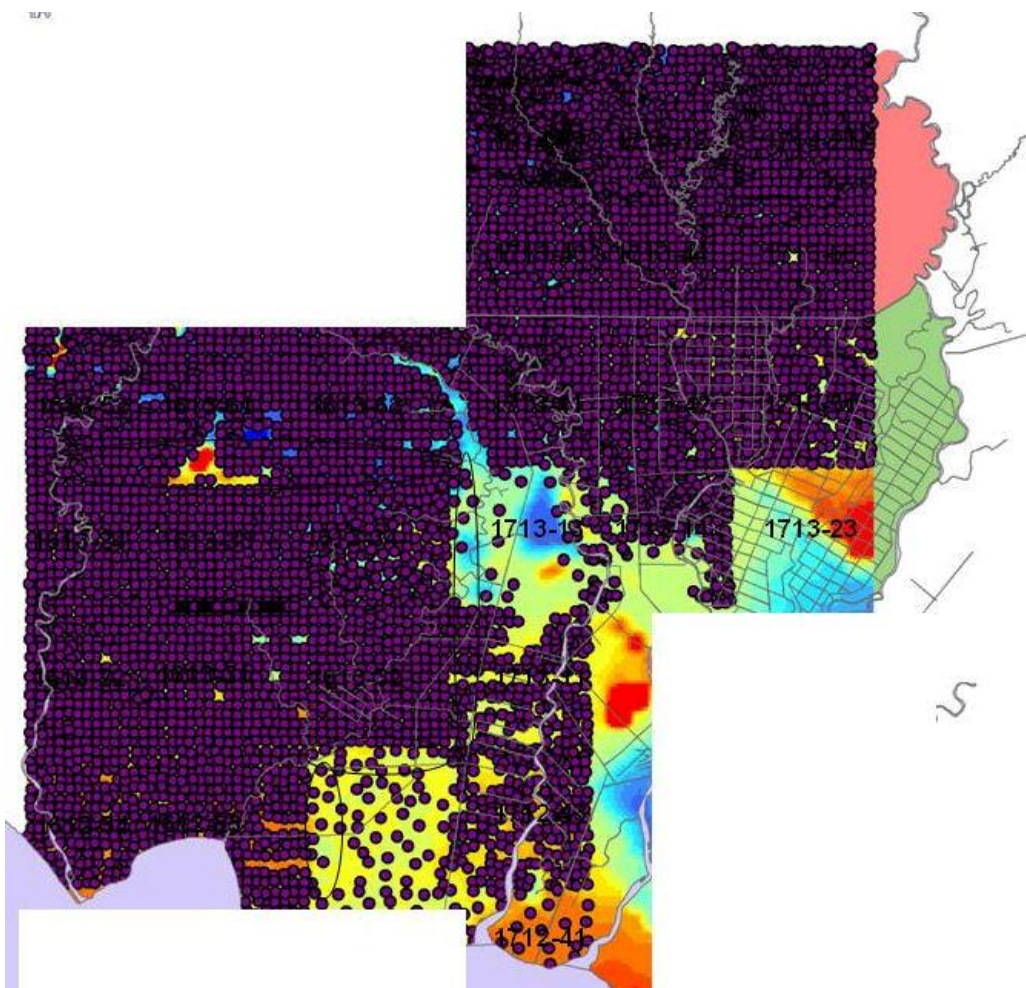
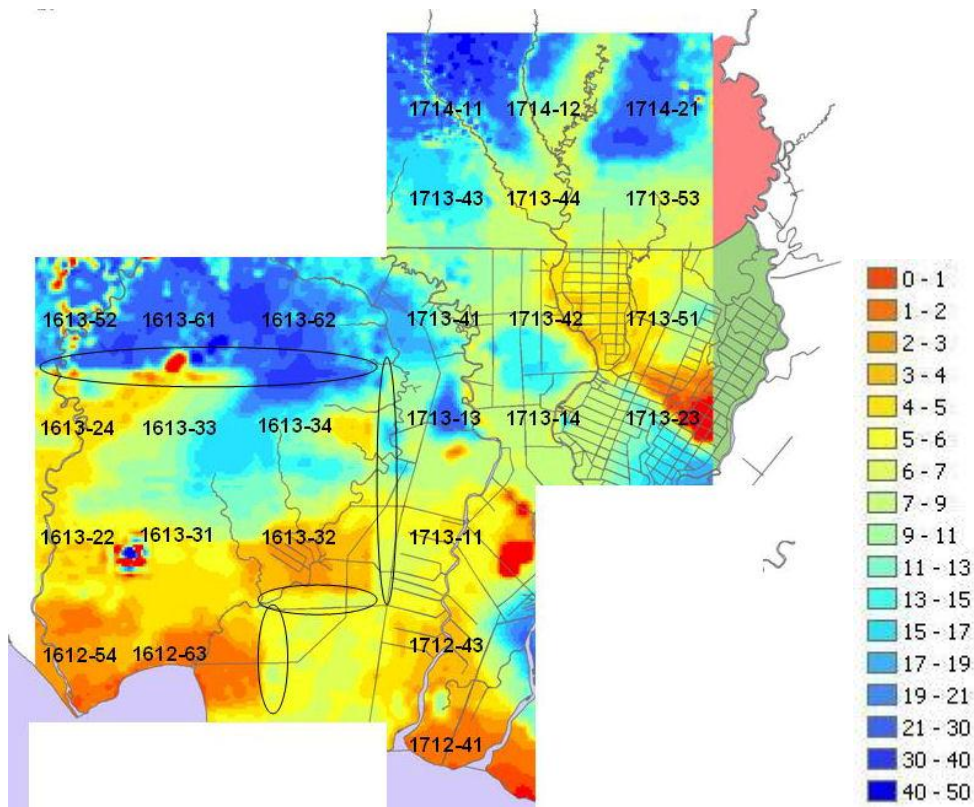
Figure 12 top: Bakosurtanal elevation points (from T-directory); bottom: spline interpolation of Bakosurtanal spot heights. The elevation does not accurately reflect actual topography in the area. ID's for the separate tiles are indicated. Black ellipsoid lines indicate some major elevation jumps. Legend in meters.

Altogether the Bakosurtanal elevation spot height data could not be used for creating a DEM for the area.

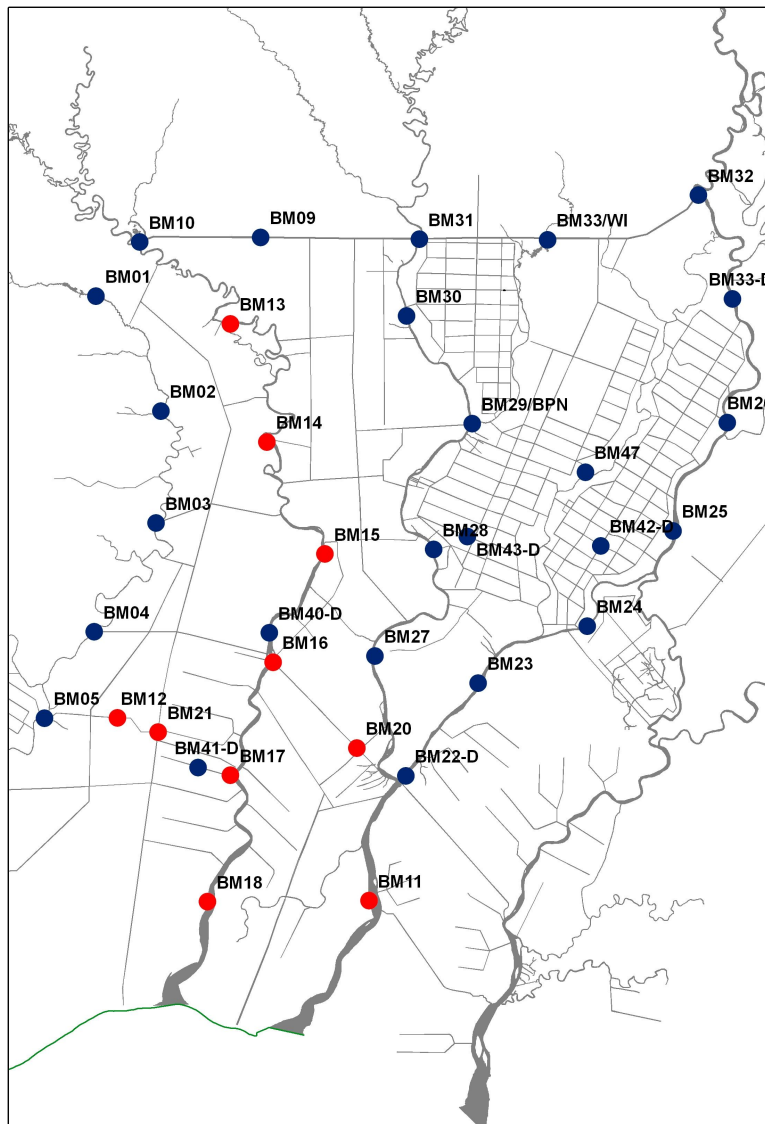
the BM description report with the dataset it was found that a total of 10 BM Id's were at the wrong location and consequently also had a different elevation (Figure 13).

Figure 13 DGPS BM locations. The red dots indicate mistaken BM Id's (and consequently also wrong elevation).

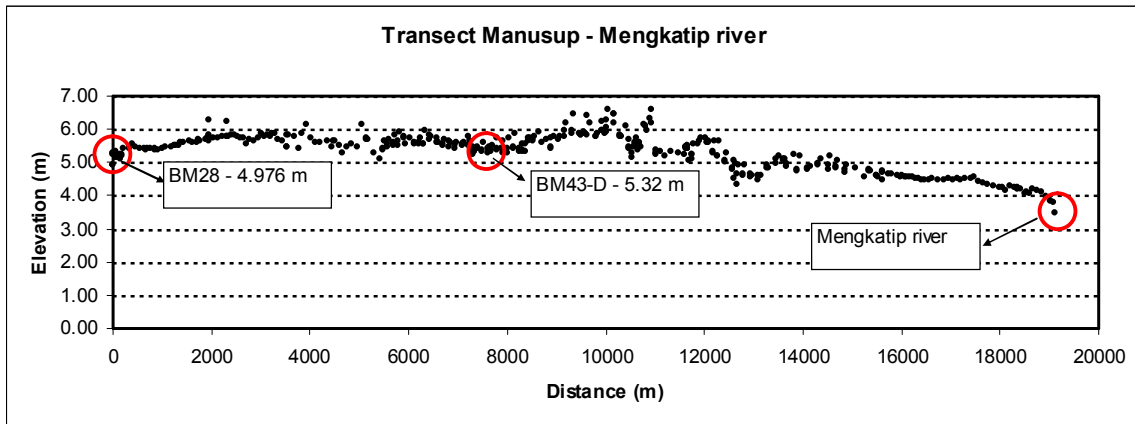
Figure 18 Profile of elevation transect from Manusup in the West and the Mengkatip river in the East starting at DGPS benchmark BM28 via BM43-D to the Mengkatip river as indicated in Figure 17.

According to the land-based elevation survey shown in Figure 18 height difference between the two benchmarks is approximately 40 cm's (5.32 - 4.976 m), whereas the official DGPS BM43-D height is 8.356 m resulting in an elevation difference of 3.38 m.

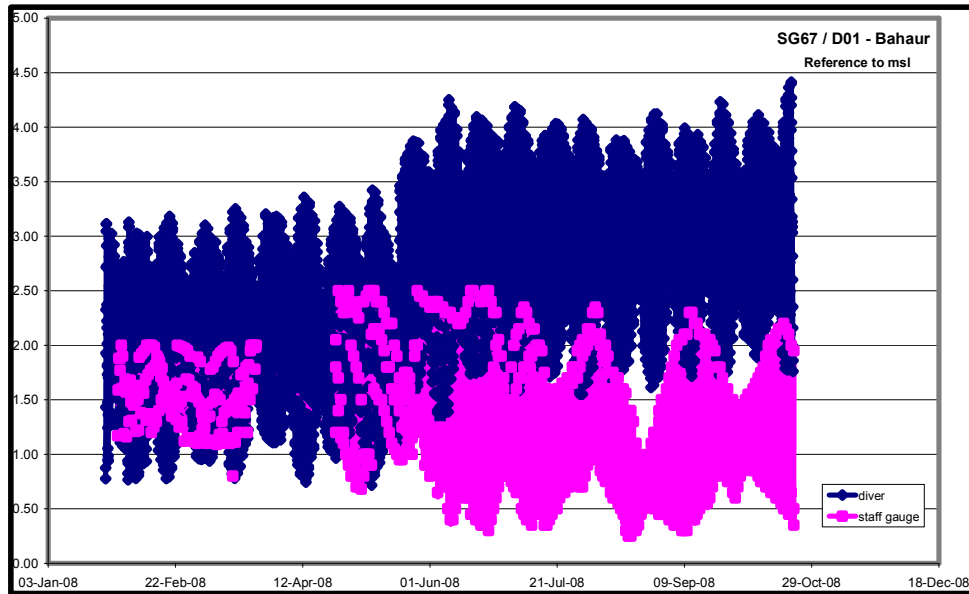
- Masalah :
- Penahan pipa Diver rusak, tutup pipa hilang
 - Staff Gauge mulai mengalami pelapukan dan marka sulit dibedakan (Cat ditutupi lumut)
 - Pengamat tidak terlalu memperhatikan pengamatan dan kondisi diver yang terpasang, mungkin karena kesibukan
- Solusi :
- Perlu perbaikan Penahan pipa Diver dan pemberian tutup pipa
 - Perlu Penggantian/perbaikan Staff Gauge
 - Perlu dipikirkan penggantian pengamat

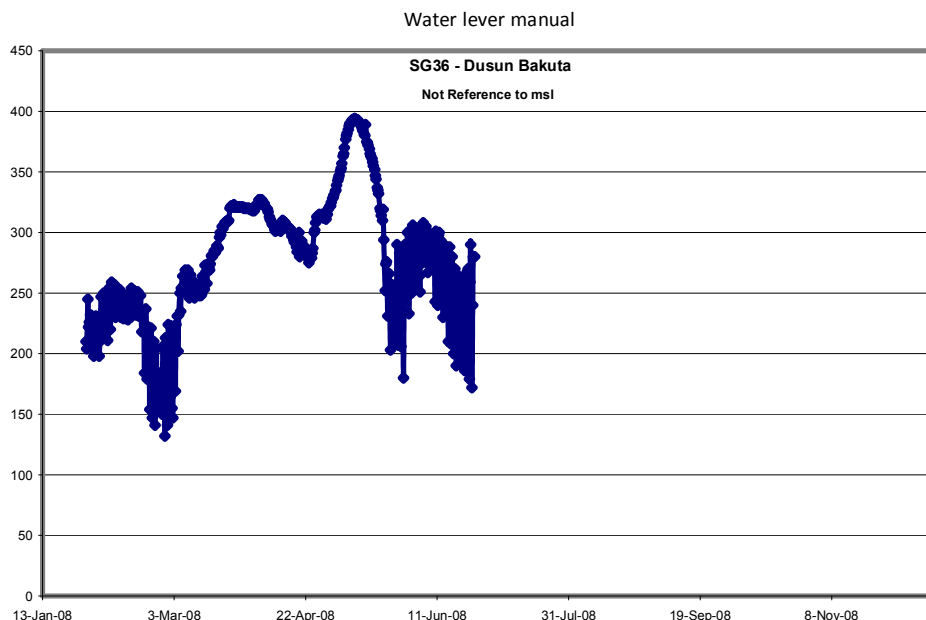
Masalah	: - Tiang penahan pipa Diver patah dan rusak (kunjungan lapangan 17 – 25 Oktober 2008 hanya perbaikan seperlunya) - Staff Gauge mulai mengalami pelapukan dan marka sulit dibedakan - Diver mengalami kerusakan
---------	---

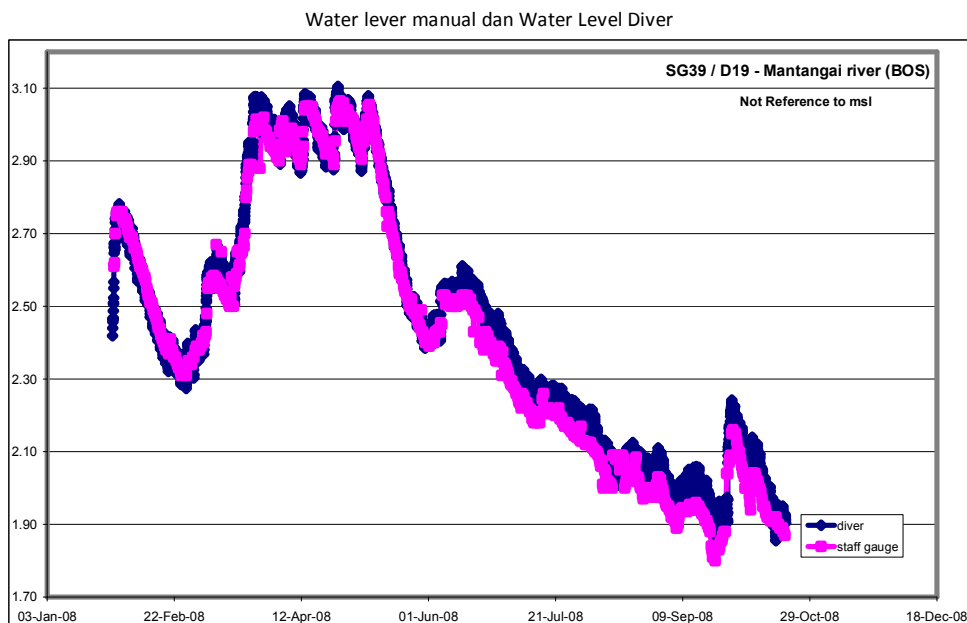
Masalah	: - Tempat peletakan Diver sering mendapat gangguan dari kapal yang berlabuh - Staff Gauge mengalami pelapukan dan tulisan angka mulai sulit dilihat
---------	--

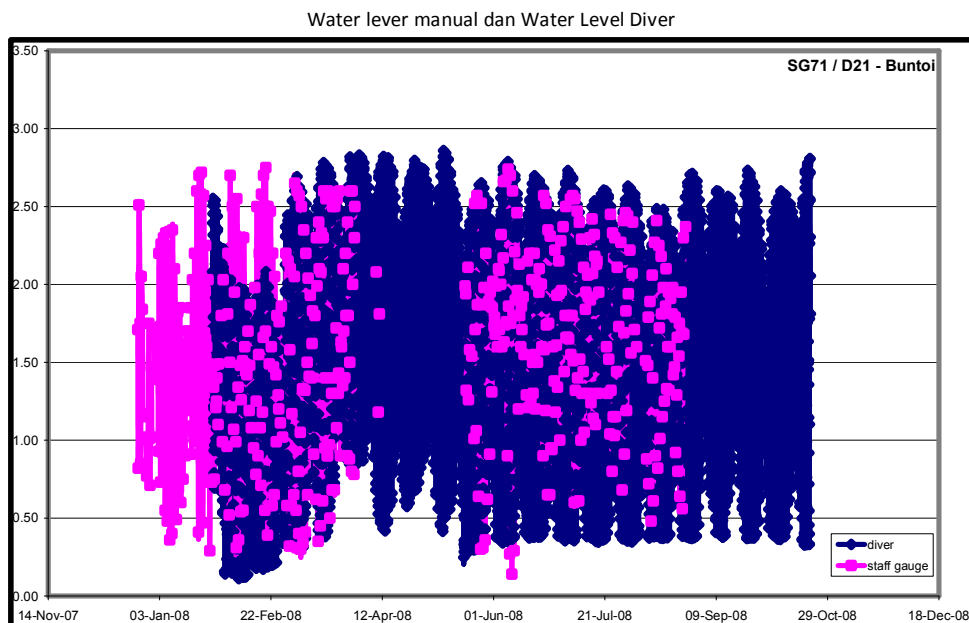
Masalah	: - Pengamat tidak terlalu serius dengan kegiatan pengamatan yang dilakukan, sering tidak melakukan pengukuran tanpa penjelasan apapun. - Posisi Diver sering mengalami gangguan dari kapal yang ingin berlabuh dan tiang penahan Diver tidak terlalu kuat
---------	---

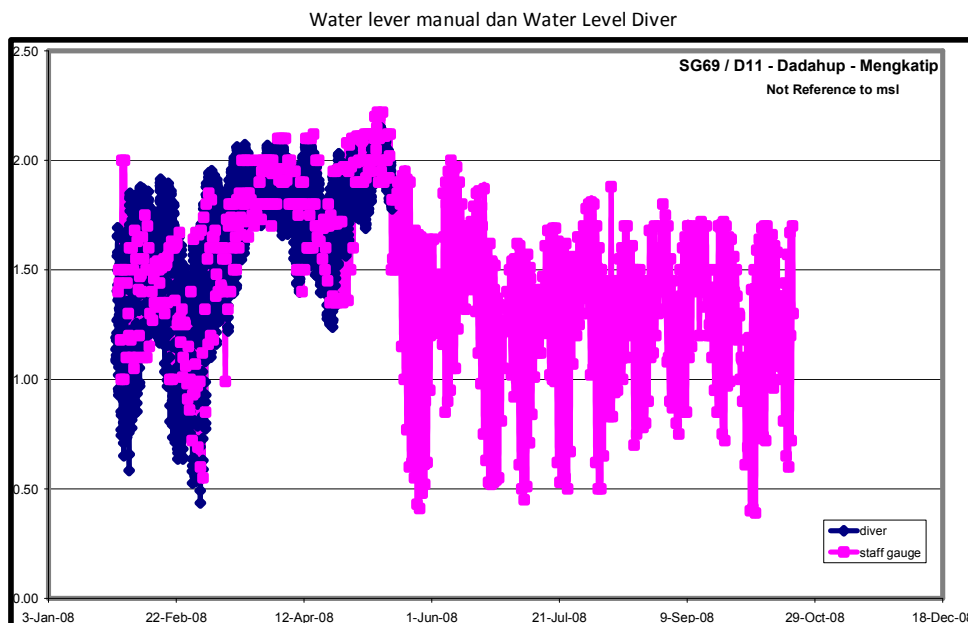
Masalah	: - Diver rusak, untuk sementara diver diambil untuk pengecekan - Staff Gauge mulai mengalami pelapukan/kerusakan dan warna terlihat kabur
---------	---

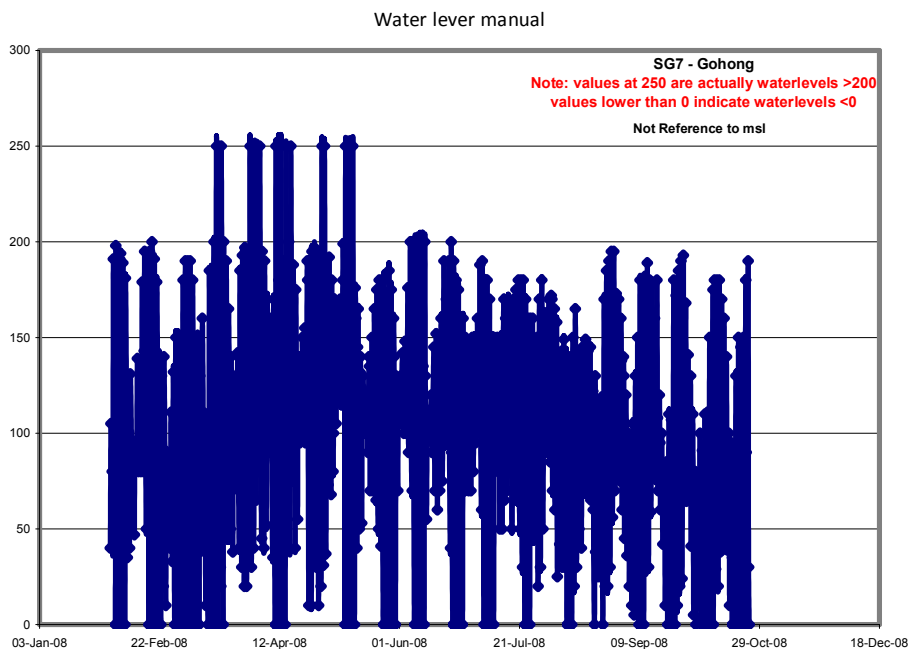
Masalah : – Staff gauge kurang panjang
– Staff Gauge mengalami pelapukan/kerusakan dan warna terlihat kabur

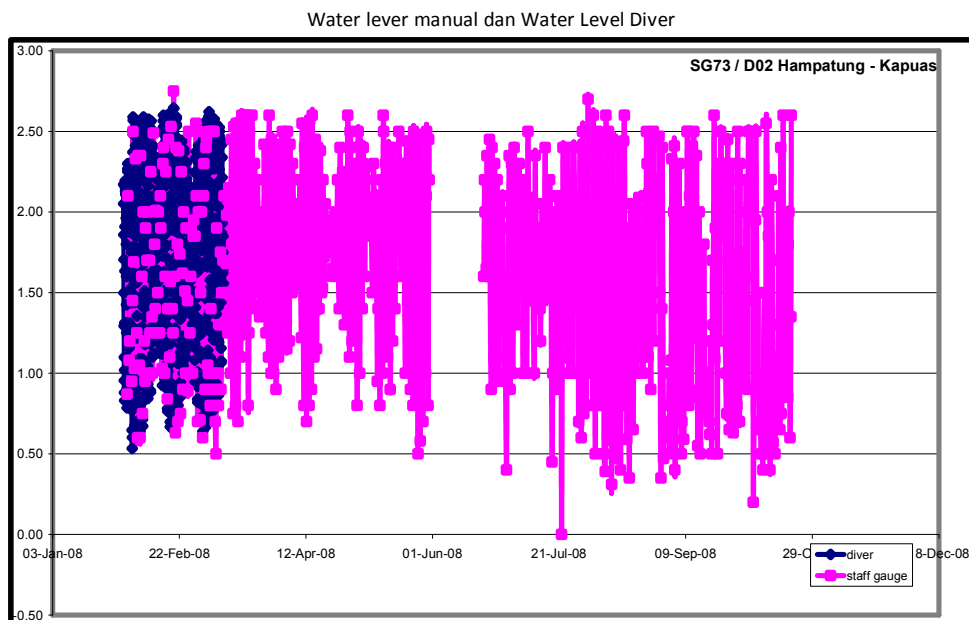
Masalah	: - Penahan pipa dan Diver rusak, untuk sementara diver diambil untuk pengecekan : - Staff Gauge mulai mengalami pelapukan/kerusakan dan warna terlihat kabur : - Tanggal, 3 desember 2008, Holdiansyah melaporkan pipa tempat diver, hilang dicuri.
---------	--

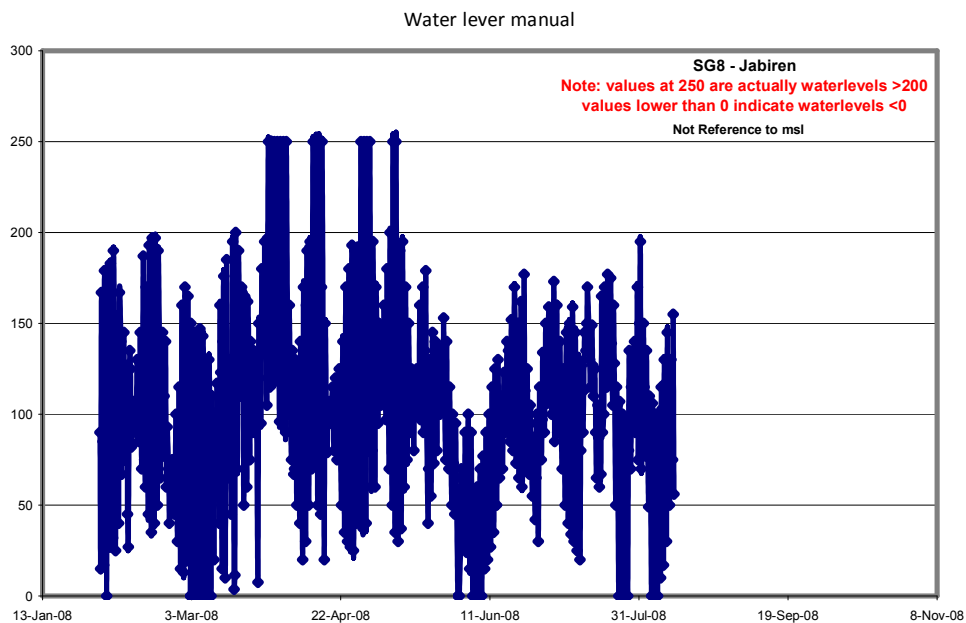
Masalah	: - Staff Gauge kurang panjang - Staff Gauge mengalami pelapukan/kerusakan dan warna terlihat kabur
---------	--

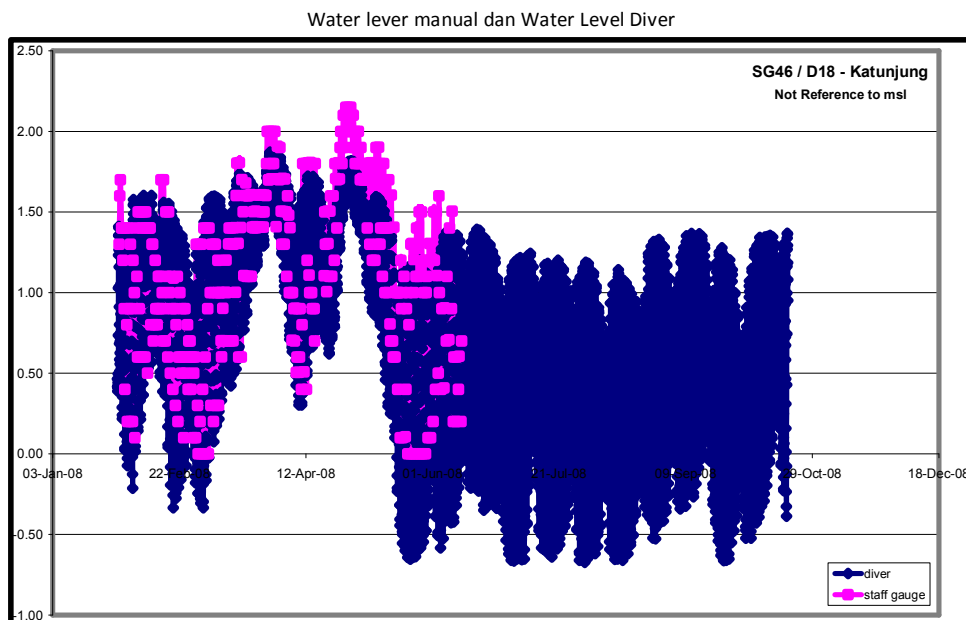
Masalah : - Staff Gauge mengalami pelapukan/kerusakan dan warna terlihat kabur

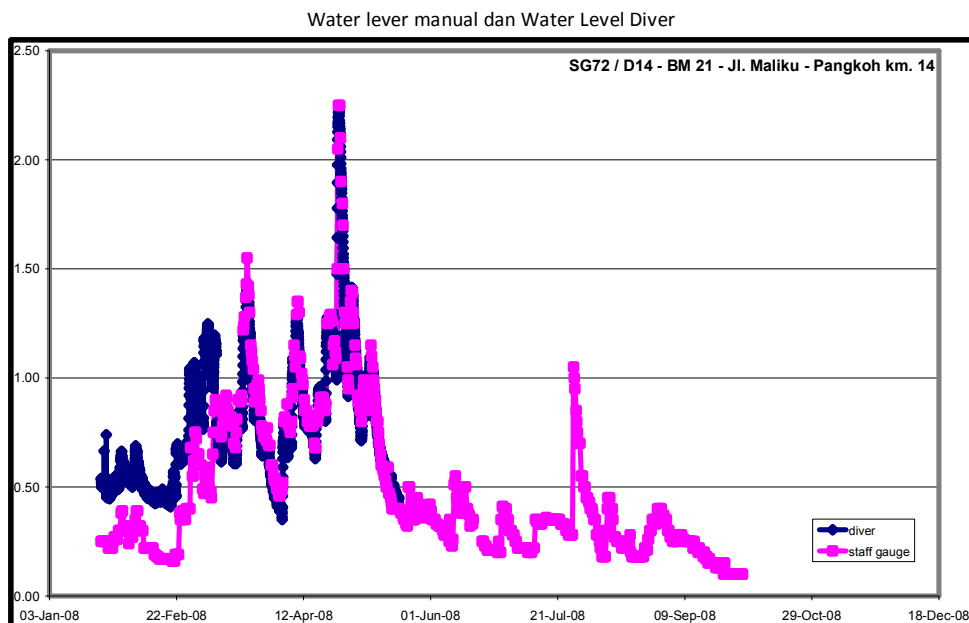
Masalah : - Diver hilang

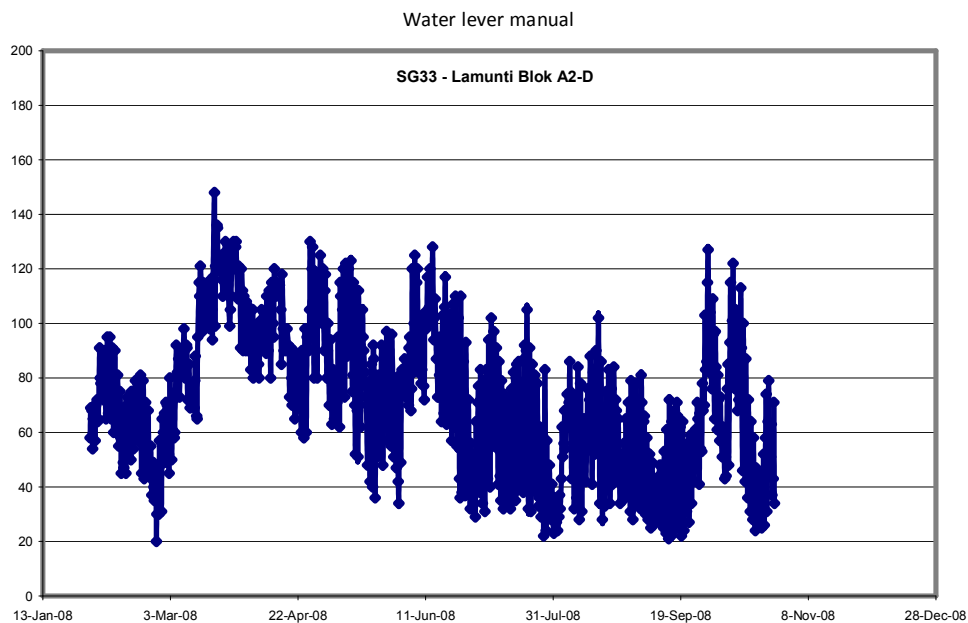
Masalah : - Staff Gauge patah, mengalami pelapukan/kerusakan dan warna terlihat kabur
