The Middle Cuanza Development

An account is given of the construction of the first dam and power station, of 260-MW capacity, at Cambambe on the River Cuanza in Angola. The Middle Cuanza represents one of the major water-power resources of Africa

PART TWO

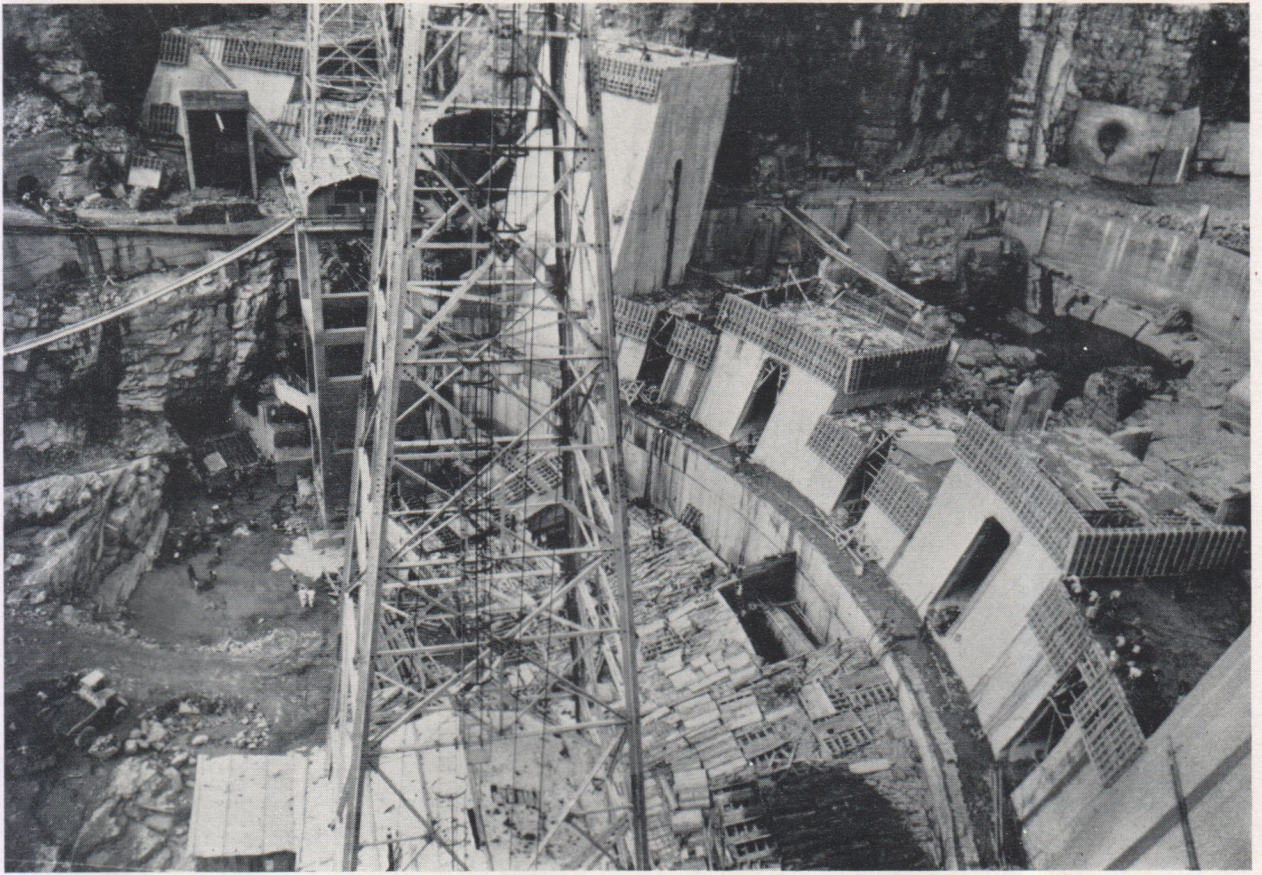
Fig. 10. A recent view of Cambambe dam under construction

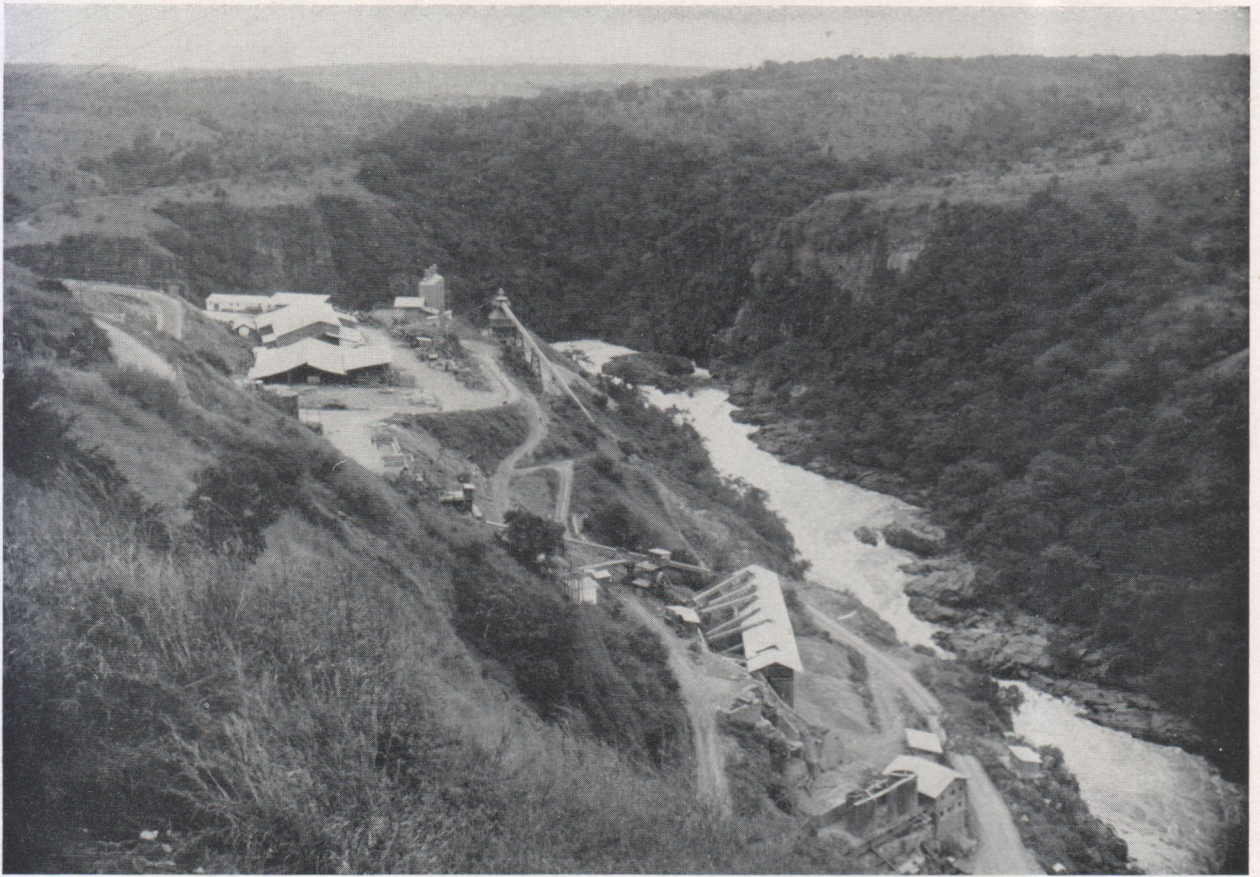
Fig. 11. A general view of the crushing, screening and washing plant

The crushing, screening and washing plant (Fig. 11) was designed for an output of 100 tons per hour. Aggregates, divided in to seven sizes, are stored in nine silos with a total capacity of 1,000 m³, three for sand up to 1.5-mm size and six for coarse aggregates up to 150 mm. Aggregate is delivered to the concrete plant by a conveyor with an output of 100 tons per hour. Cement is being supplied by Companhia Secil do Ultramar, from Luanda, and is transported in 5-ton steel containers, by railway as far as Dondo, and by truck in a road haul of 20km to the concrete mixing plant, where the containers are unloaded and the cement conveyed to storage silos or directly to the mixing plant, by a pneumatic conveyor.

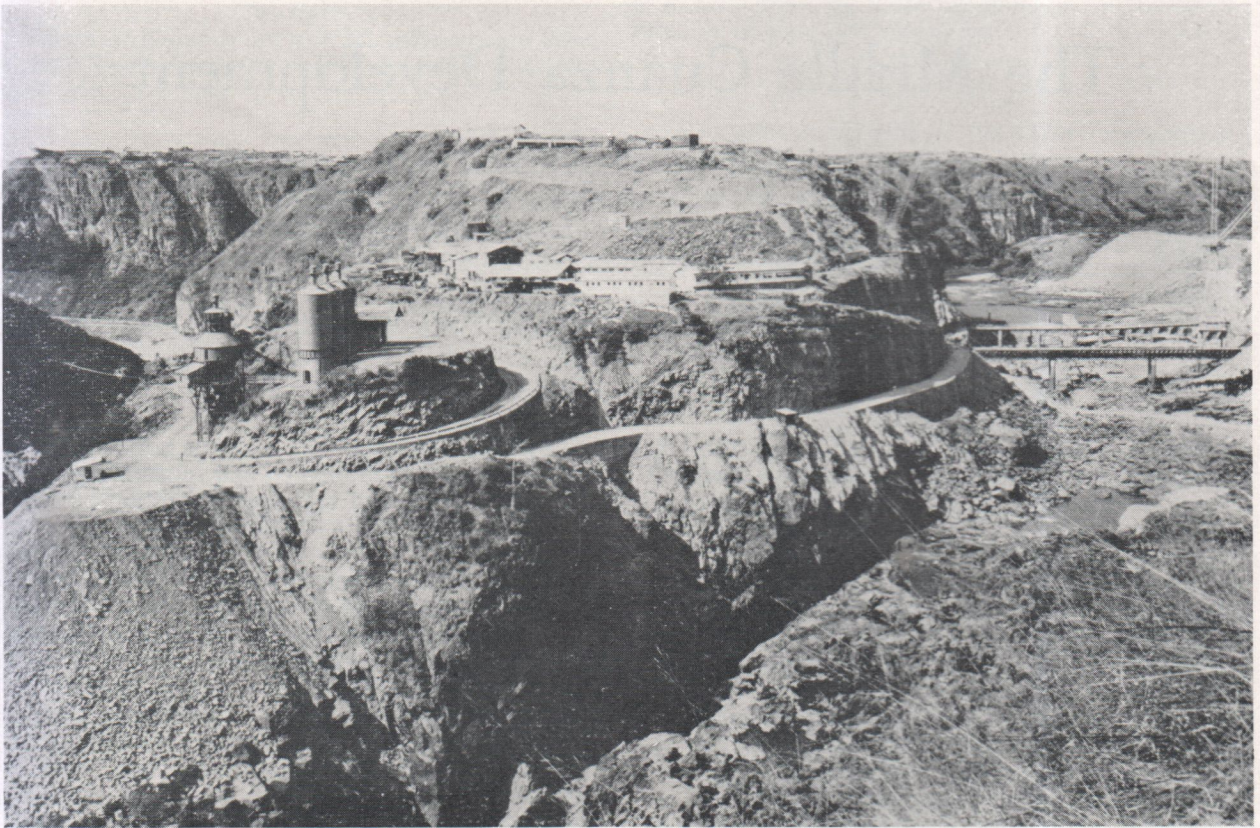
Fig. 12. In this photograph can be seen the two sides of the river bend which are connected by the underground power plant below the hill in the centre. The concrete-mixing plant is in the foreground and the dam site on the extreme right

The concrete plant (Fig. 12) is equipped with an automatic batching system, with an hourly output of 60 m³. Materials for batching are stored in eight bin compartments with a capacity of 360 m³. There are three 1-m³-capacity concrete mixers of the Winget-Koehring type, and an electro-pneumatic batching system effects the simultaneous weighing of seven aggregates, cement and water, their registration, and the control of the mixing time. Concrete transfer from the mixing plant around the works is made in dumper trucks. Concrete is placed in the dam by four 6-ton 60-m Loro & Parisini derricks, the concrete being dumped from the dumpers into buckets on a Bailey service bridge. Forms are built with Angola wood, of good quality, coming

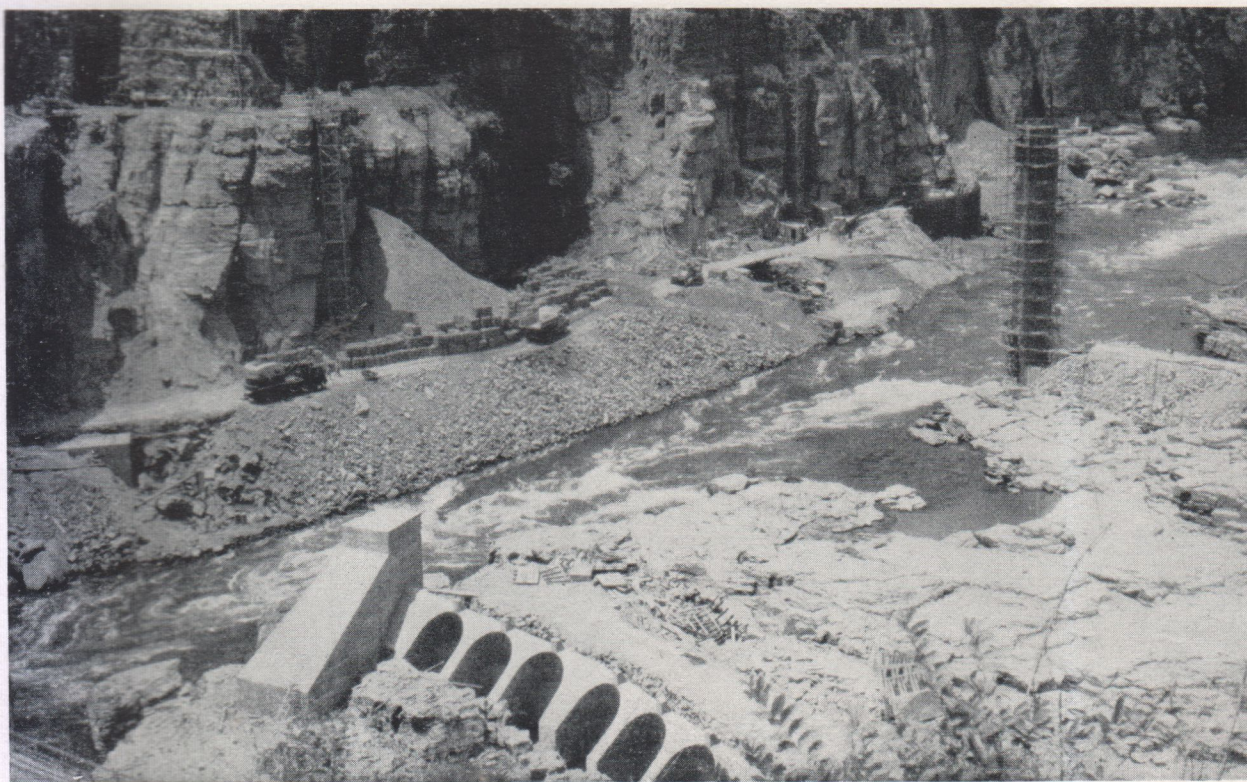
Fig. 15. Preparatory operations for diverting the river. The "obelisk" can be seen standing on the right ready to be thrown across the river

To enable the permanent cofferdam to be built it was decided to construct a temporary rockfill cofferdam a little way upstream, and to reduce the flow sufficiently to enable this cofferdam to be placed, a reinforced-concrete pillar, or "obelisk," seen in Fig. 15, was built on one bank ready to be overturned and dropped across the river.
