Report on Site Visit to Japan (19-25 October 2008)

by Djoko Luknanto¹

Collaboration project on monitoring methods of archeological monuments have been carried out between National Research Institute for Cultural Properties, Tokyo (NRICPT), Japan and Borobudur Heritage Conservation Office (BHCO), Indonesia. The collaboration aims to share and exchange knowledge, expertise and experience of monitoring methods of monuments.

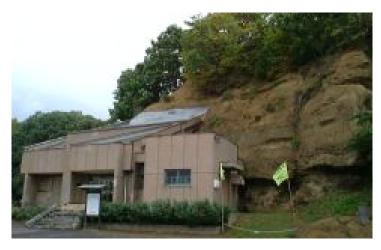
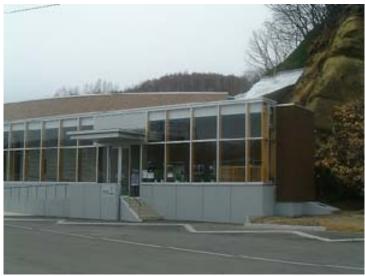
Visitors to the Fugoppe cave cannot see the original opening from the surrounding. The Fugoppe office was built in front of the cave (see Figure 2). The office served the purpose for (1) protecting the cave from the detrimental effect of visitors and weather, (2) for giving information to visitors, (3) the place for monitoring equipments. The office itself has been renovated several times.

Figure 2. The old and new office building of the Fugoppe Cave (http://www.amateras.com/trip/japan/hokkaido/otaru-e.htm)

- Due to weather and some physical considerations, both caves are surrounded by the modern building to accomodate all the neccessary monitoring and protection scenarios, therefore the originality of the cave opening cannot be found anymore by visitors. In the future, it might be important to take the balanced consideration between preserving the originality of the cave opening (conservation aspect) and the protection/monitoring of the caves. In Indonesia, for comparison, there are many caves that has the prehistorical paintings. Some of the found in Maros and Pangkep areas. In this case, the opposite situation happened. The cave is still in the original state, but the monitoring and protection aspect a bit more difficult to carry out (see Figure 11).

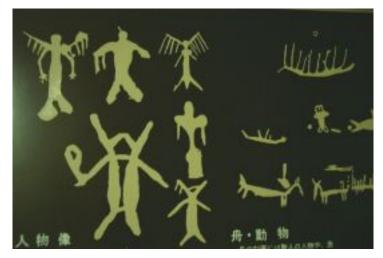
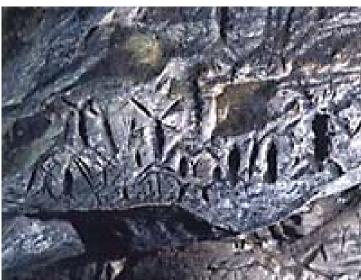
The walls are covered by 2,000 years old engravings showing mostly human figures. Some of them have wings and look like angels. They belongs to the history of Post-Jomon Period, about 1500 years ago. (See Figure 3).

Figure 3. The reproduction (above) and the original painting on the cave wall (Photo Courtesy of Yoichi Town Board of Education, Hokkaido)

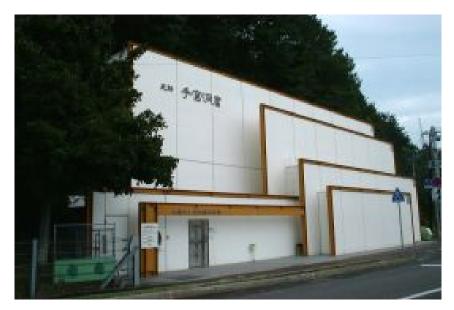
Temiya cave situated at the foot of small hill and also very close to the highway (see Figure 5). This cave is the first cave in Japan that has been designed and monitored with very sophisticated monitoring devices. The office equipped with very interesting video information for visitors. This information is not found in the latter developed cave office, the Fugoppe's. The monitoring devices are less sophisticated than the devices installed at Fugoppe office. At Temiya office, the daily monitoring is still recorded automatically with the roll paper; not directly connected to the computer chip. Even with the old fashioned monitoring equipments, as seen at Tamiya Cave, it is quite expensive, and it is difficult to be be adopted to other less develop countries.

Figure 4. Temiya Cave Office (http://www.amateras.com/trip/japan/hokkaido/otaru-e.htm)

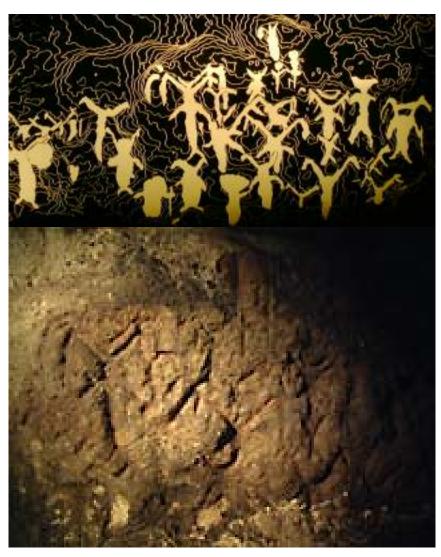
Temiya Cave is only a small remains of a cave, which is of great archaeological interest. It contains cave carvings and Inkoku paintings from the Zoku-Joumon period of Ainu history, about 400 AD (see Figure 5).

Figure 5. The reproduction (above) and orginal (below) Temiya Cave painting (Photo Courtesy of Yoichi Town Board of Education, Hokkaido)

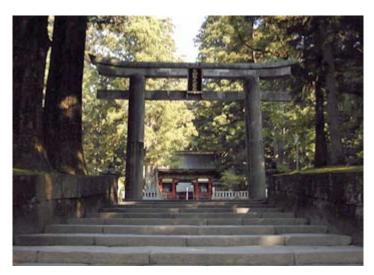
The Ishidorii has remained in its original form since its construction in 1618. The torii gate, which is 9.2 m tall and 13.2 m wide, is made out of 15 blocks of stone, instead of wood, which is the material usually used for torii (see Figure 6).

Figure 6. The Ishidorii, a torii gate, constructed from stones (http://www.city.nikko.lg.jp/kankou/shaji/english/main.htm)

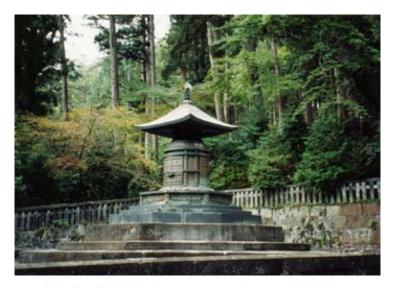
The Okusha Hoto was originally a wooden building when first constructed in 1622, but was remodeled into a stone structure in 1641. The bronze pagoda, which we see now, is a 1683 reconstruction, built after an earthquake destroyed the stone building (see Figure 7).

Figure 7. The Okusha Hoto, bronze pagoda, is a 1683 reconstruction (http://www.city.nikko.lg.jp/kankou/shaji/english/main.htm)

- During the visit to the Hokusa Hoto (see Figure 7), it was found that the interlocking between two stone blocks was replaced by bronze lock. Due to the oxidation between metal (bronze) and the sorrounding air, the bronze lock was deteriorated. In this case, it much better to use stone to make the lock. At Borobudur World Heritage Site, this kind of lock is always used, since it is more natural to the surrounding stone blocks (see Figure 12).

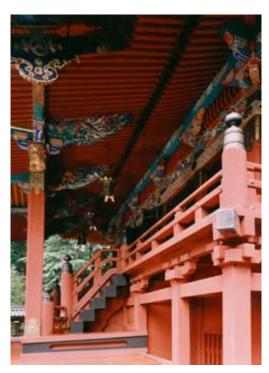
The Honden was originally constructed in 1619 as the main hall of Futarasan-jinja. It was relocated from its original location to the present location when a couple of accompanying halls were added in 1645. Though some replacement of materials has been done for maintenance purposes involving roofing, painting and decorative metal fittings, no changes have been made as far as structural members are concerned (see Figure 8).

Figure 8. The Honden, the main hall of Futarasan-jinja (mainly constructed from wood) (http://www.city.nikko.lg.jp/kankou/shaji/english/main.htm)

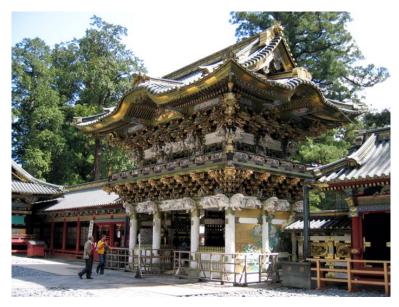
Figure 9. Nikko Gate (http://upload.wikimedia.org/wikipedia/en/3/3d/Gate-nikko-japan.jpg)

One of the famous gate found in the site are the Nikko gate, which is highly ornamental with very bright coloring style (Figure 9). This style of ornaments as well as its bright coloring was found all over the place. Like any other ornaments found in the sites, there are story attached to the related ornament. One famous ornament is depicted by three monkeys closing their ears, mouth, and eyes to deliver the famous old teaching "Hear no evil, speak no evil, see no evil" (see Figure 10).
