Master Plan for the Rehabilitation and Revitalisation of the Ex-Mega Rice Project Area in Central Kalimantan

PRELIMINARY ASSESSMENT OF AVAILABILITY AND ACCURACY OF HYDROLOGICAL AND ELEVATION DATA IN THE EMRP AREA

Technical Review No. 3

MARCH 2009

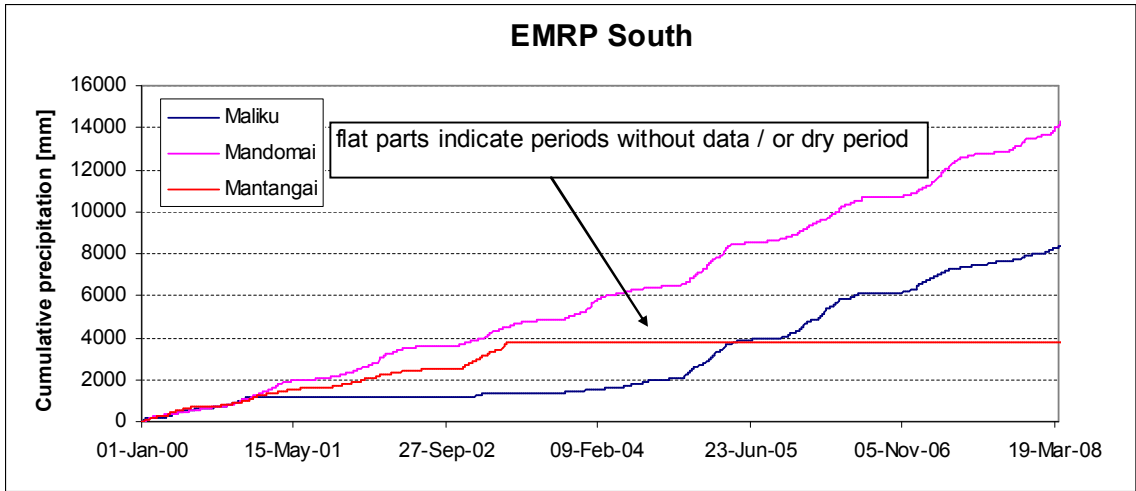
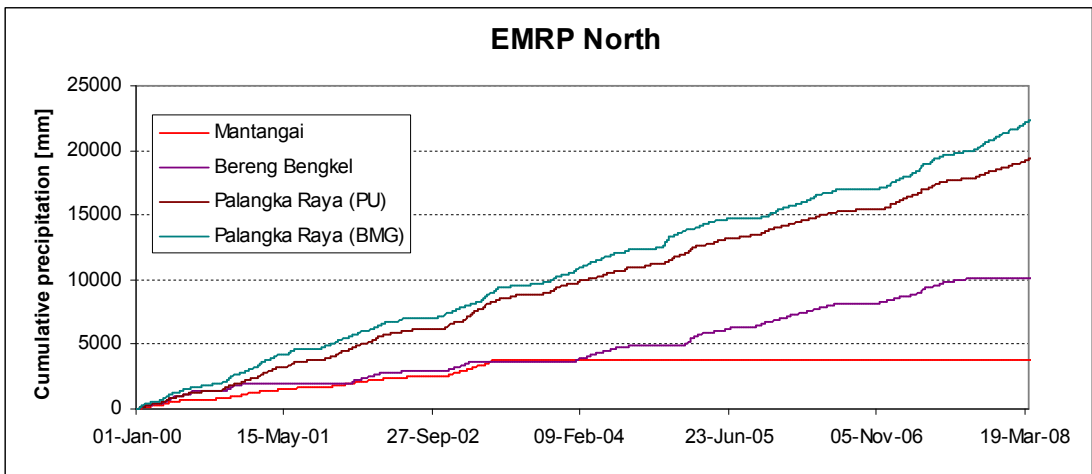
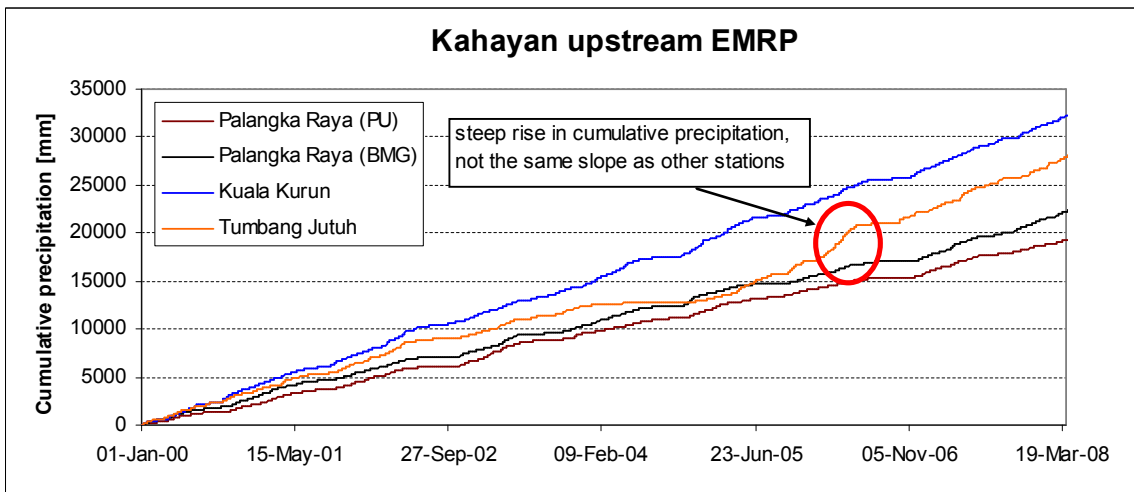
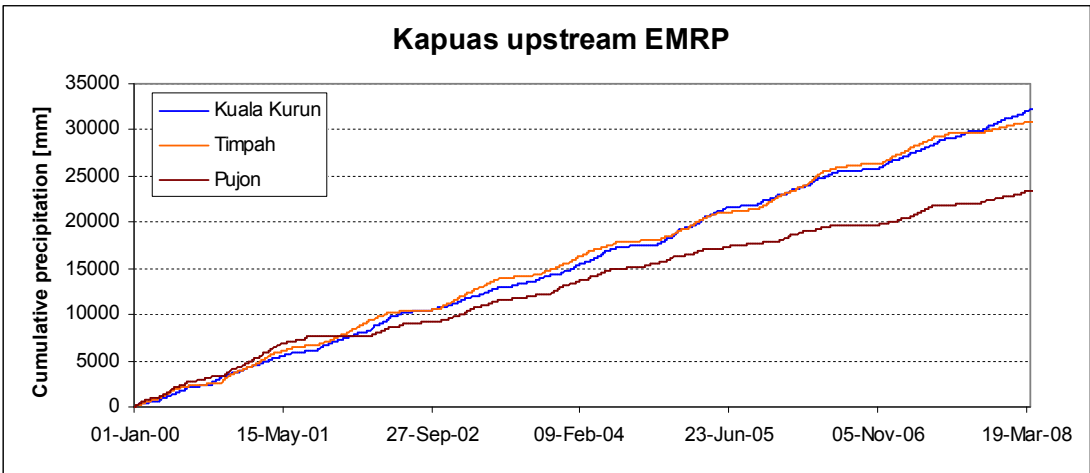
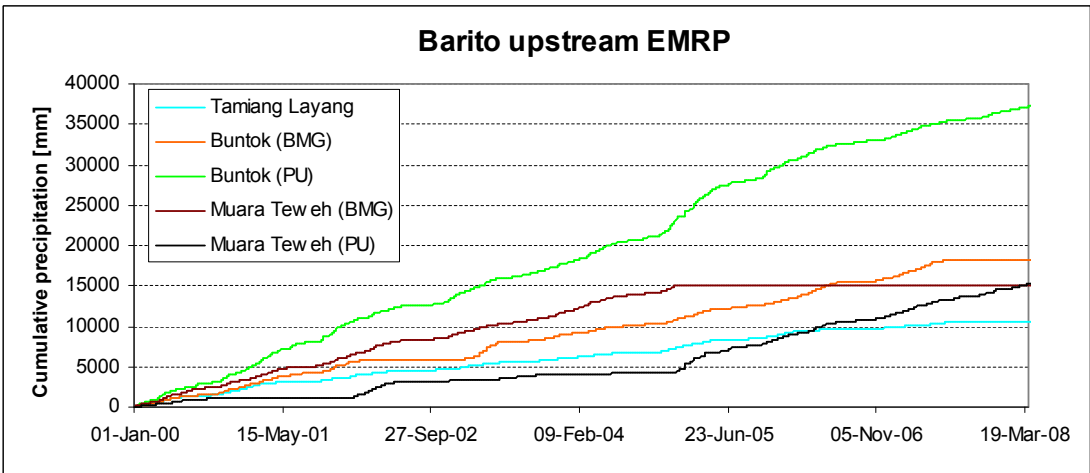
Figure 2 Cumulative precipitation of PU and BMG measurement locations over period January 2000 – April 2008. Each graph for different geographic region.

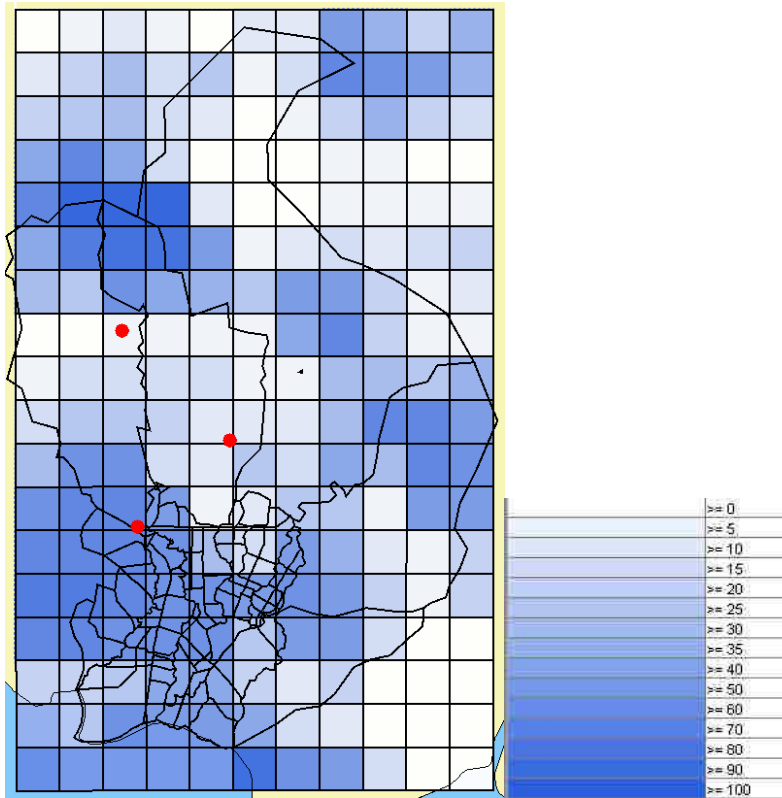
Figure 6 Precipitation map of the EMRP catchment area for 19 November 2004 as observed by TRMM. Here the localized nature of precipitation in the area is clearly demonstrated. Scale in mm. Red dots are locations of reliable PU and BMG measurement stations as indicated in Table 1 and Figure 1. Clearly, rainfall patterns in the area can not be identified by the current ground monitoring system.

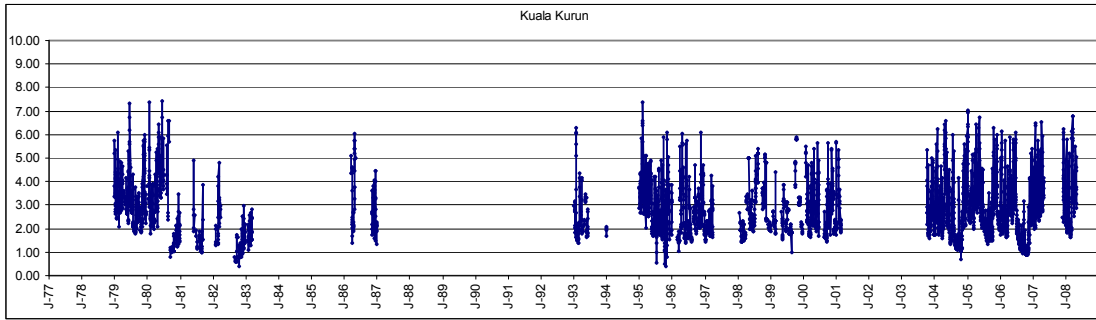
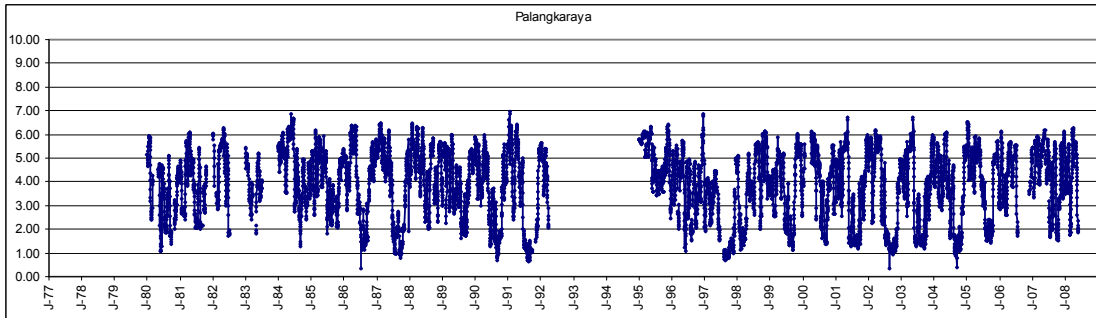
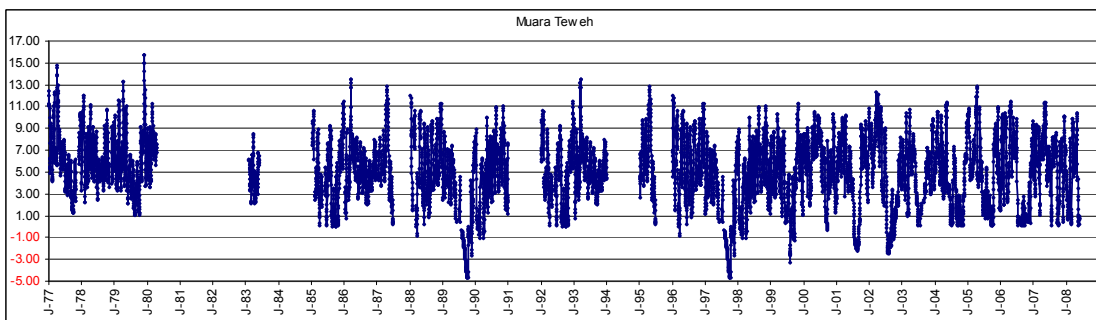
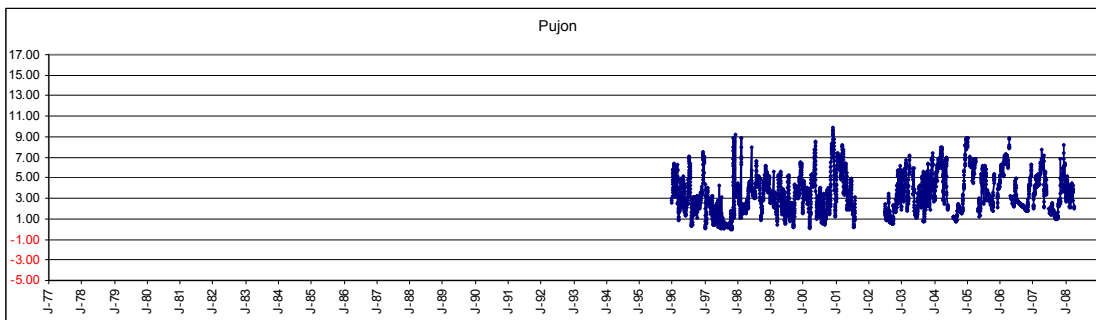
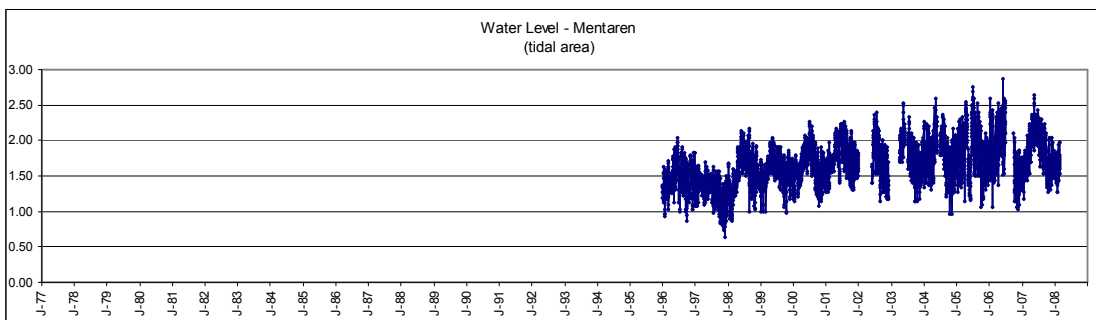
River water level time series dating back to 1979 are available for 5 PU stations, but many data gaps occur (Table 3). Only two of the stations were located in the EMRP area, the other three were north of the area. None of the water levels were referenced to mean Sea level, an important condition if one wants to use the water levels in assessing flood and tidal dynamics with a model. Referencing to mean Sea level is not possible due to the lack of accurate elevation information for the EMRP area.

Figure 9 Water level data from PU monitoring stations.

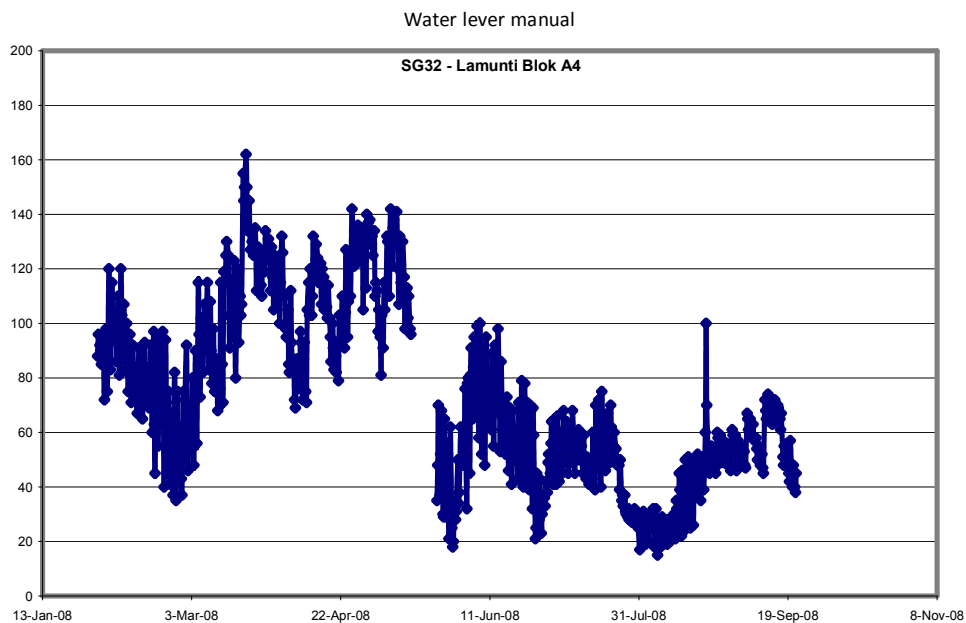
Masalah : - Staff Gauge mengalami pelapukan/kerusakan dan warna terlihat kabur

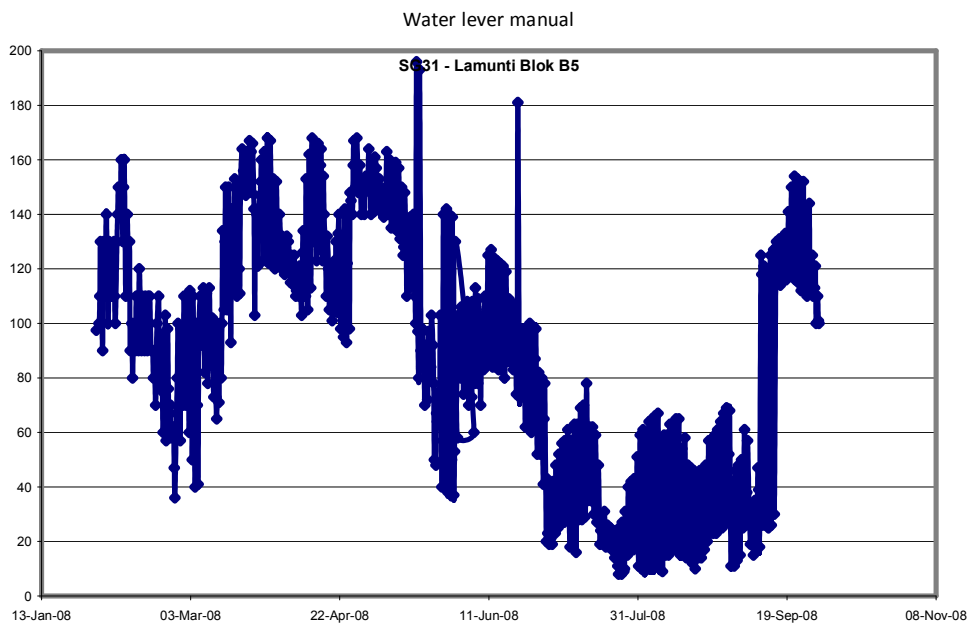
Masalah : - Staff Gauge patah, mengalami pelapukan/kerusakan dan warna terlihat kabur

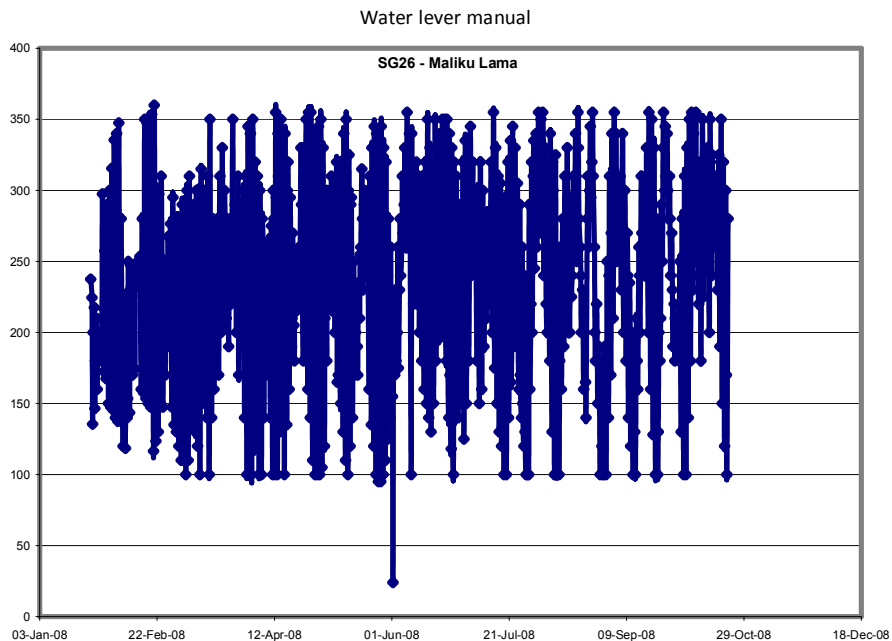
Masalah : – Staff Gauge kurang panjang
– Staff Gauge mengalami pelapukan/kerusakan dan warna terlihat kabur

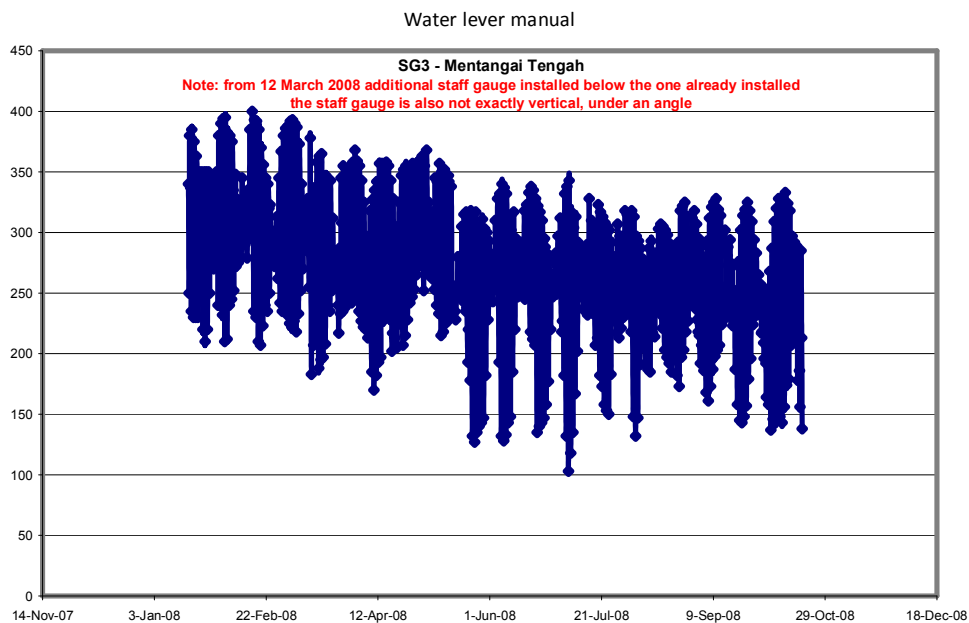
Masalah	: - Staff Gauge mengalami pelapukan/kerusakan dan warna terlihat kabur - Posisi staff gauge miring
---------	---

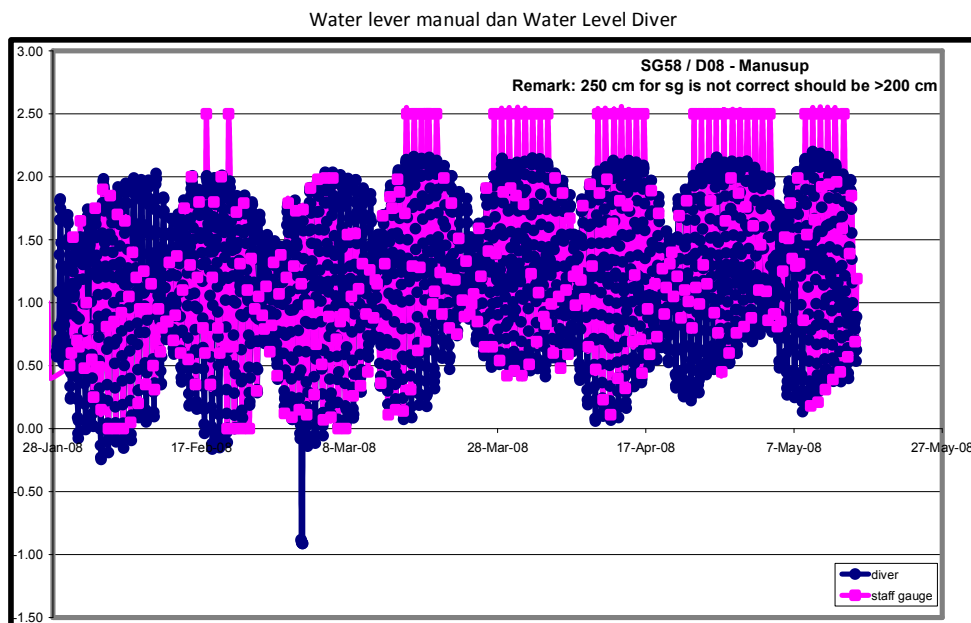
Masalah	: - Staff gauge rusak dan Diver hilang - Sejak Field visit Oktober 2008, Manusup belum memiliki pengamat
---------	---

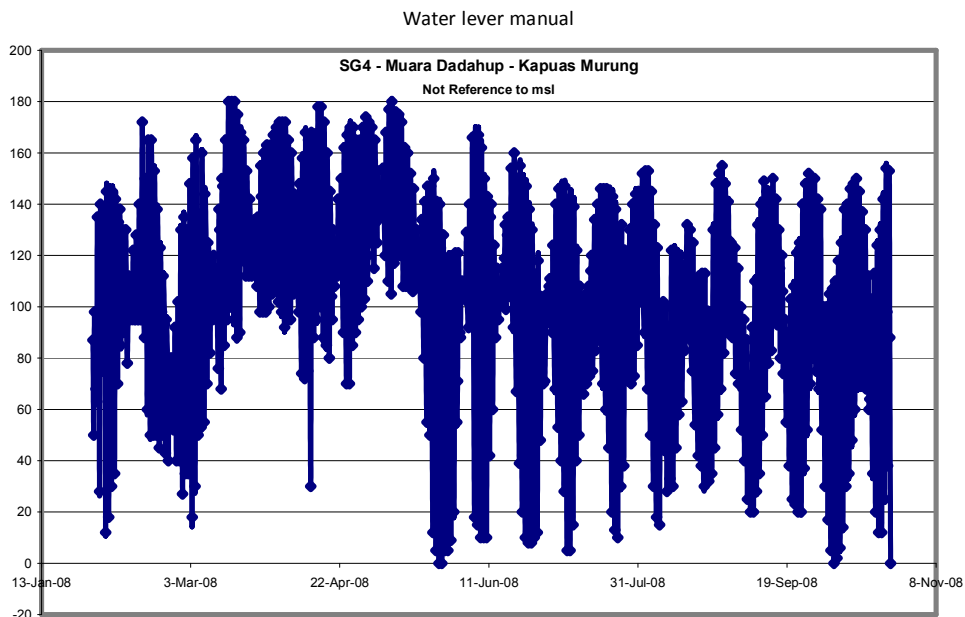
Masalah :
: – Staff Gauge kurang panjang
– Staff Gauge mulai mengalami pelapukan/kerusakan dan warna terlihat kabur

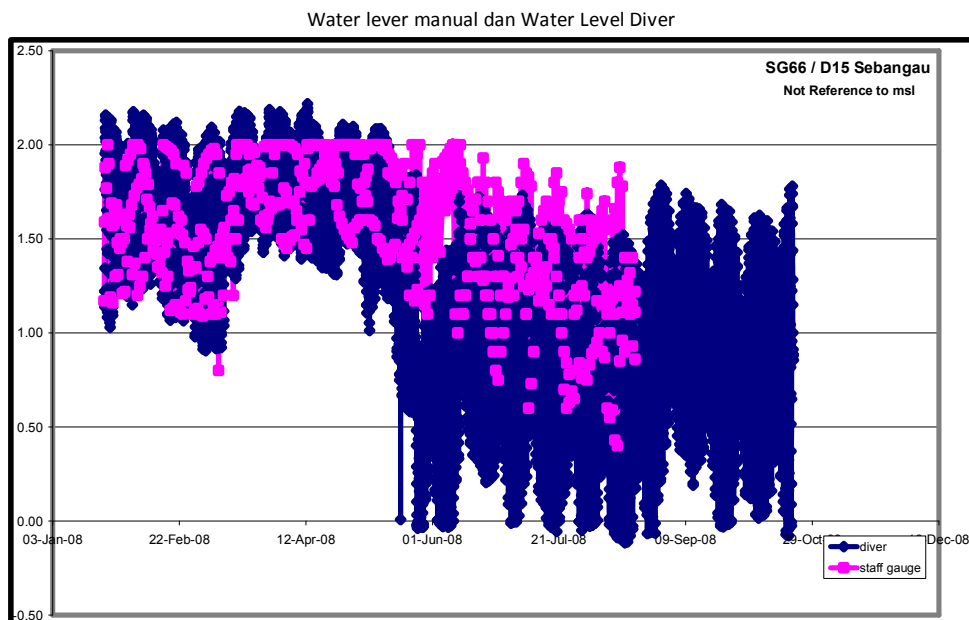
Masalah	: - Staff gauge kurang panjang : - Staff Gauge mulai mengalami pelapukan/kerusakan dan warna terlihat kabur
---------	--

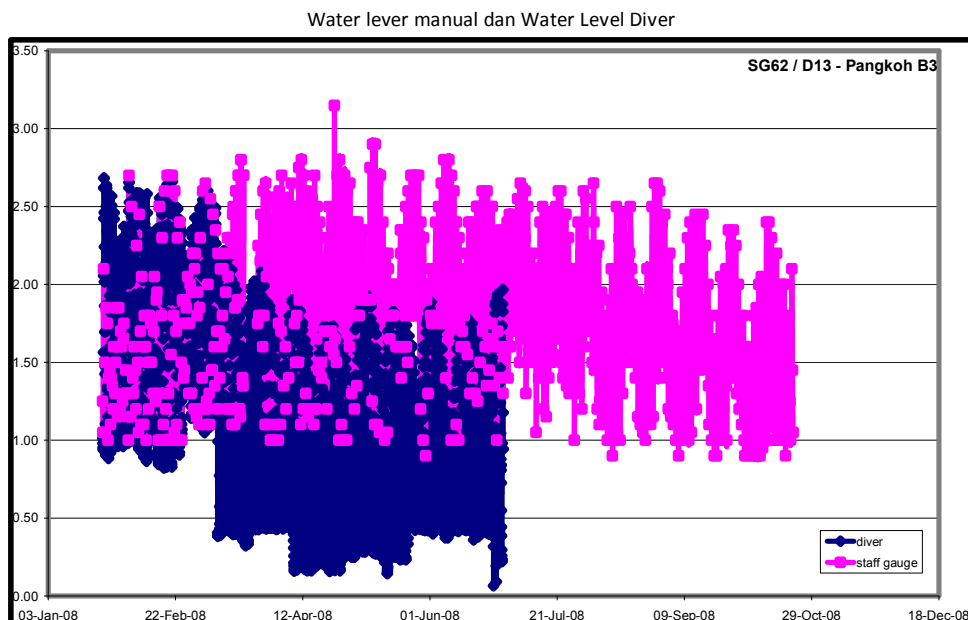
Masalah	: - Diver rusak, Data tidak merekam data sejak 29 Juni 2008, walaupun terlihat dalam kondisi baik dan bisa didownload, diver tetap pada lokasi pemasangan - Pada kunjungan lapangan 22 Oktober 2008, Info Ibu Nurbaya, Staff Gauge diketahui patah dan disambung sementara dengan menggunakan bahan seadanya dan warna masih terlihat kabur walaupun sudah
---------	---

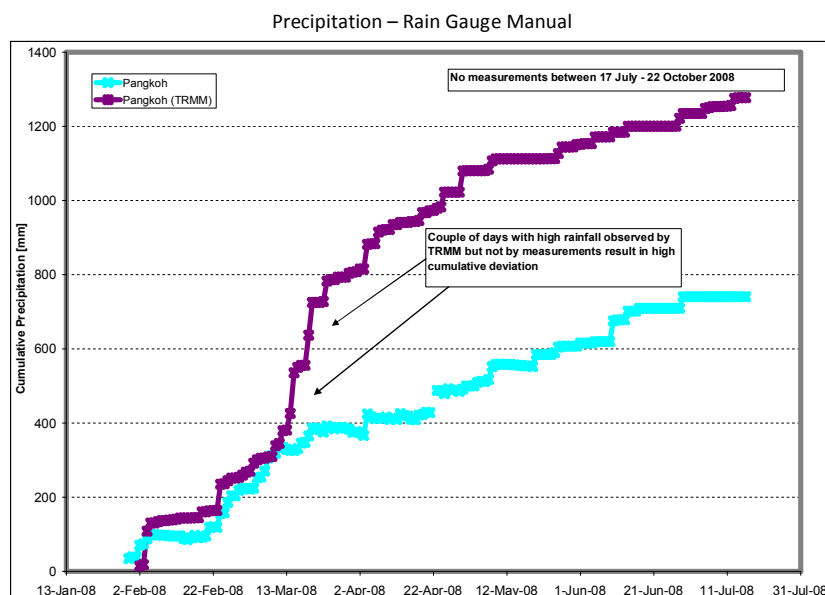
Masalah	: - Tiang tempat pemasangan Rain Gauge mengalami kerusakan (dilakukan perbaikan seadanya pada kunjungan lapangan tanggal 22 Oktober 2008) - Alat pengukur air menggunakan alat seadanya
---------	---

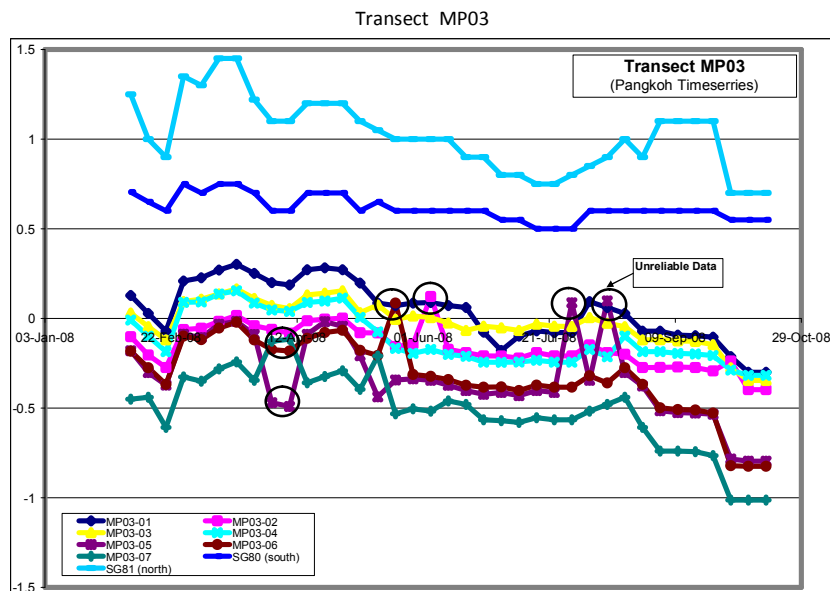
Masalah : - Pengukuran Staff Gauge dibulatkan ke angka puluhan terdekat, sehingga data kurang akurat

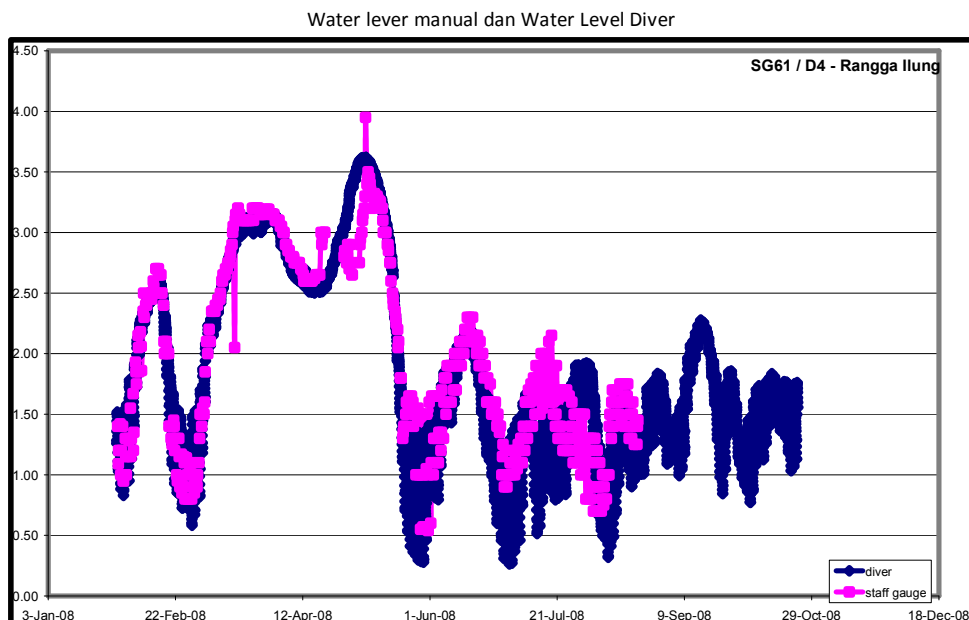
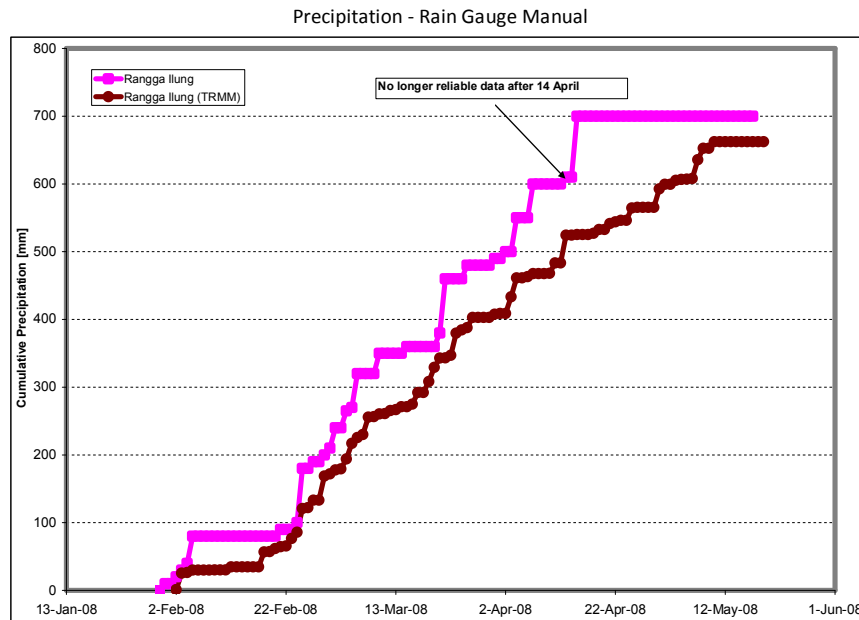
- Masalah :
- Letak Rain Gauge tidak sesuai dengan syarat penempatan rain gauge
 - Pipa, tali penggantung diver dan pengikat pipa pada tiang Dermaga mengalami kerusakan
 - Cat pada Staff Gauge terlihat kabur
 - Takaran air (milliliter) diragukan

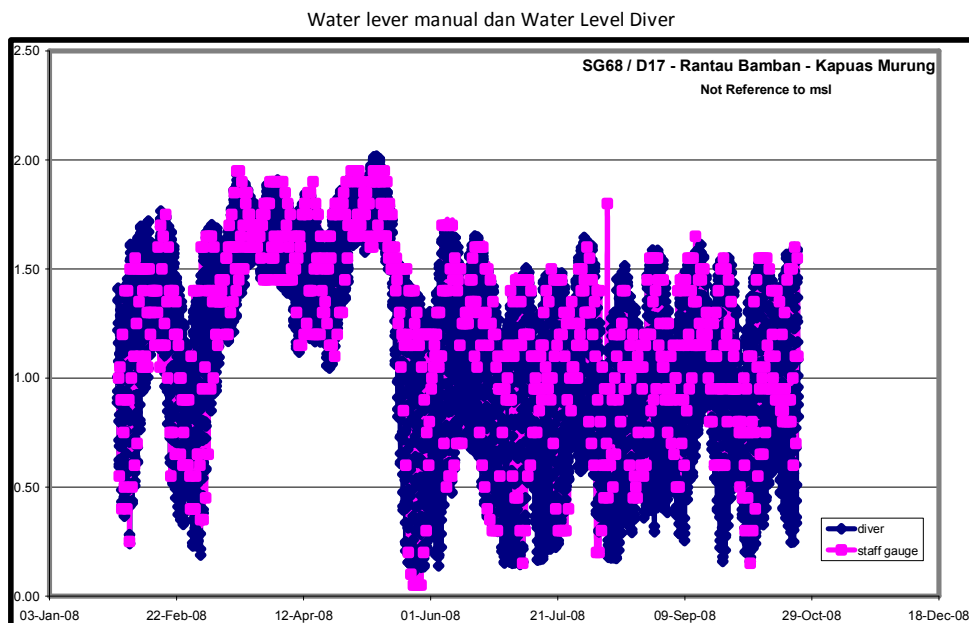
Masalah	: - Staff gauge kurang panjang - Staff Gauge mengalami pelapukan dan tulisan angka mulai sulit dilihat
---------	---
